Sawmills

ADA Transition Plan

This report will identify barriers within municipally owned buildings as well as barriers within the pedestrian right of way. The pedestrian right of way includes any infrastructure meant for pedestrian utilization. Mobility hazards are identified during walking audits and documented in a Pedestrian Right of Way Collector Application. The application collects a broad range of data and has criteria for sidewalks, curb ramps, driveway cuts, intersections, railroad crossings, bus stops, crosswalks, and pedestrian islands.

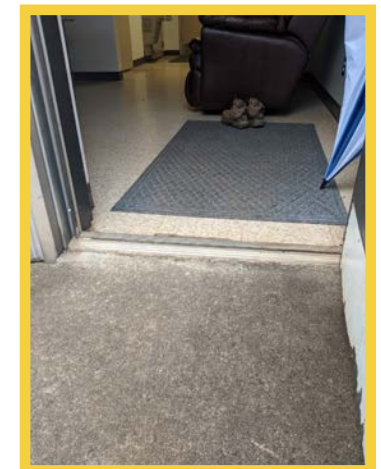
| High Priority | Moderate Priority | Low Priority |
|---|---|---|
| » n/a | » n/a | <ul style="list-style-type: none"> » Threshold coming in at the exterior door could become a trip hazard. Thresholds cannot be higher than ¼" high. <ul style="list-style-type: none"> » Note: The threshold can be ½" high with the top ¼" beveled to be no steeper than 1:2 if the threshold was installed on or after the 1991 ADA Standards went into effect. » Or no more than ¾" high with the top ½" beveled no steeper than 1:2 if the threshold was installed before the 1991 ADA Standards went into effect on January 26, 1993. |

Threshold coming in at the exterior door could become a trip hazard.

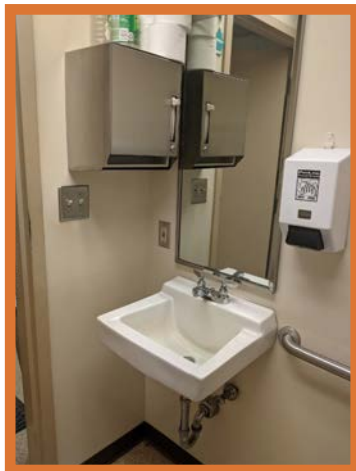
Pipes should be insulated

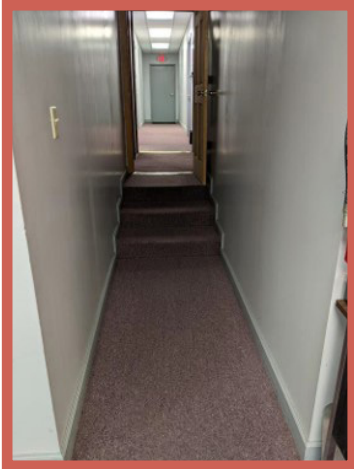
There are currently steps throughout Town Hall and no accessible route around them.

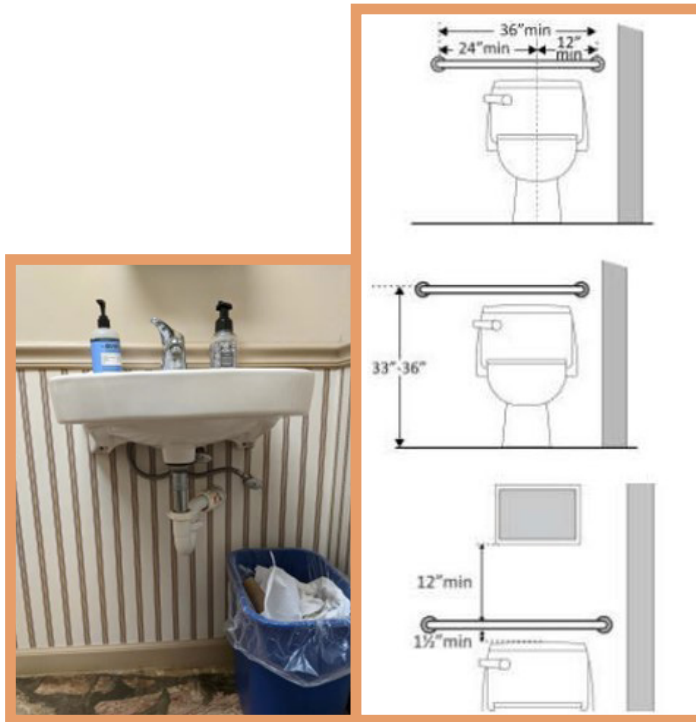
Rear grab bar should meet designated requirements.

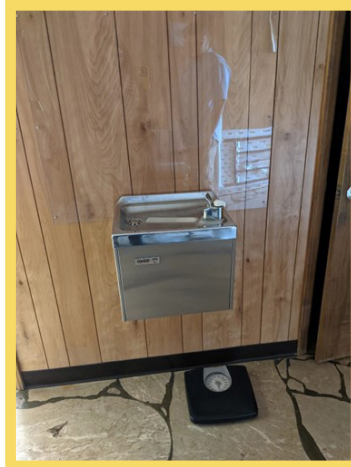
Fountain does not meet current design standards.

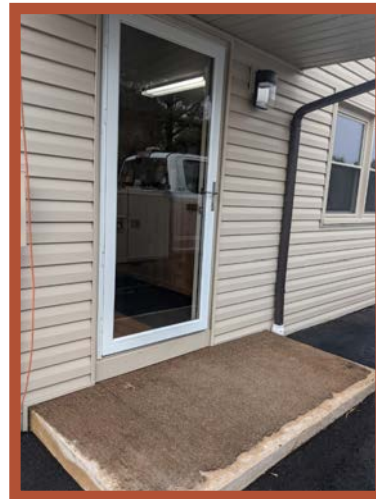
Entrance should be flush

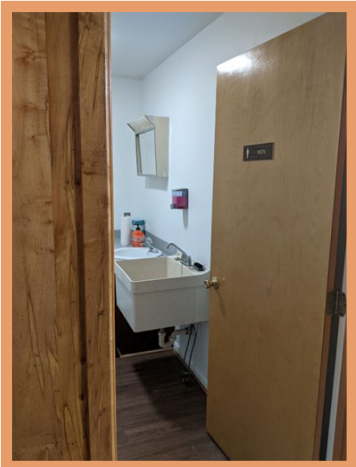
Signage should be in braille and mounted on latch side of door

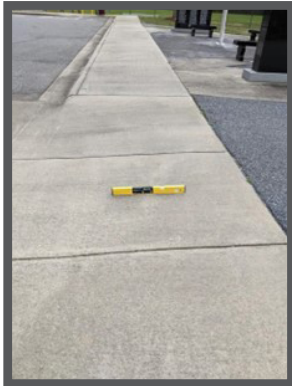
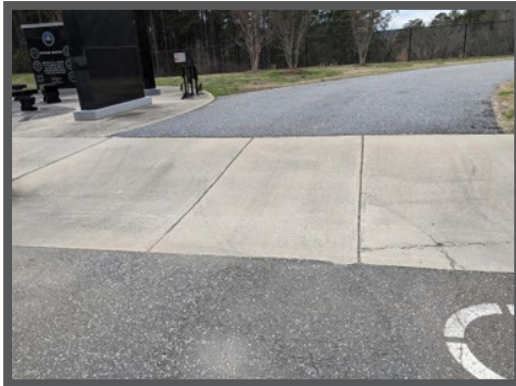
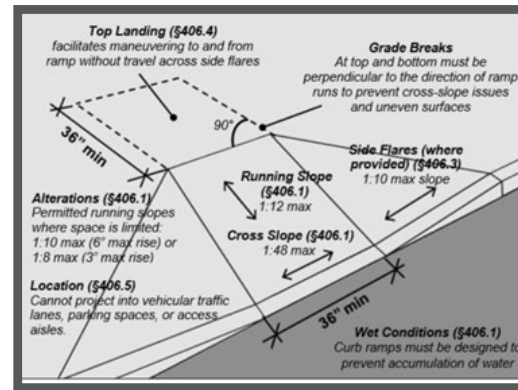
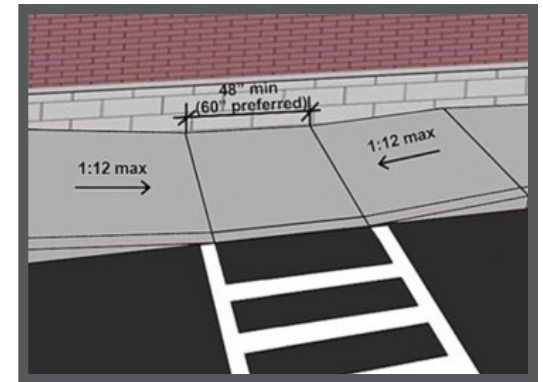
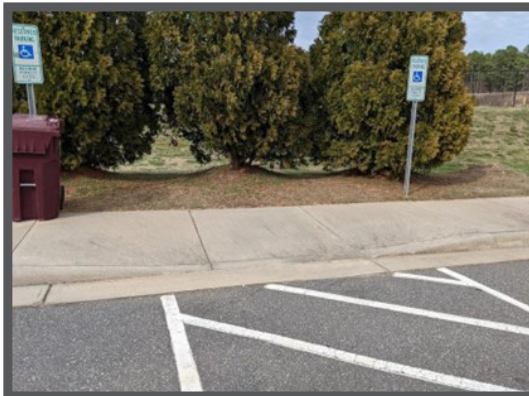
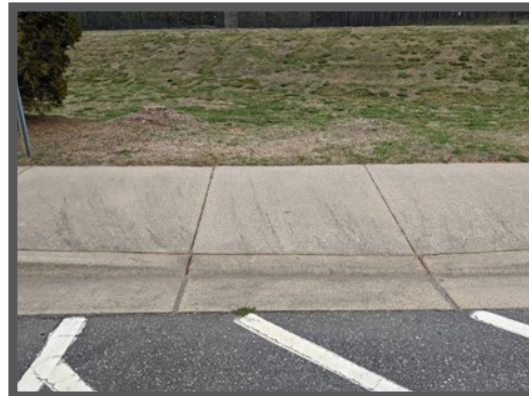
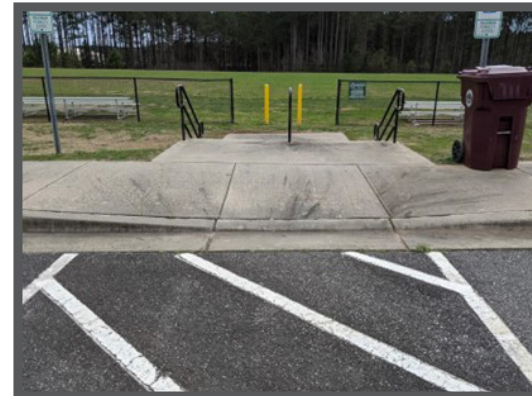
- » Driveway cuts that cross pedestrian routes must have a 2% or less cross slope.
- » The curb ramps at the accessible spaces (closest to the restrooms) have no level landing and creates a 5% cross slope for pedestrians using the sidewalk. Example curb ramp types are shown below. The first example shows a top landing that prevents pedestrian hazards when crossed. The second example shows parallel curb ramps used for confined spaces. The limited slope and flat landing prevents pedestrian hazards.

The curb ramp closest to the soccer field has a top landing right next to the stairs. Recommend high-viz striped tape on the stairs as well as directional signage showing the nearest accessible route. (high recommendation)

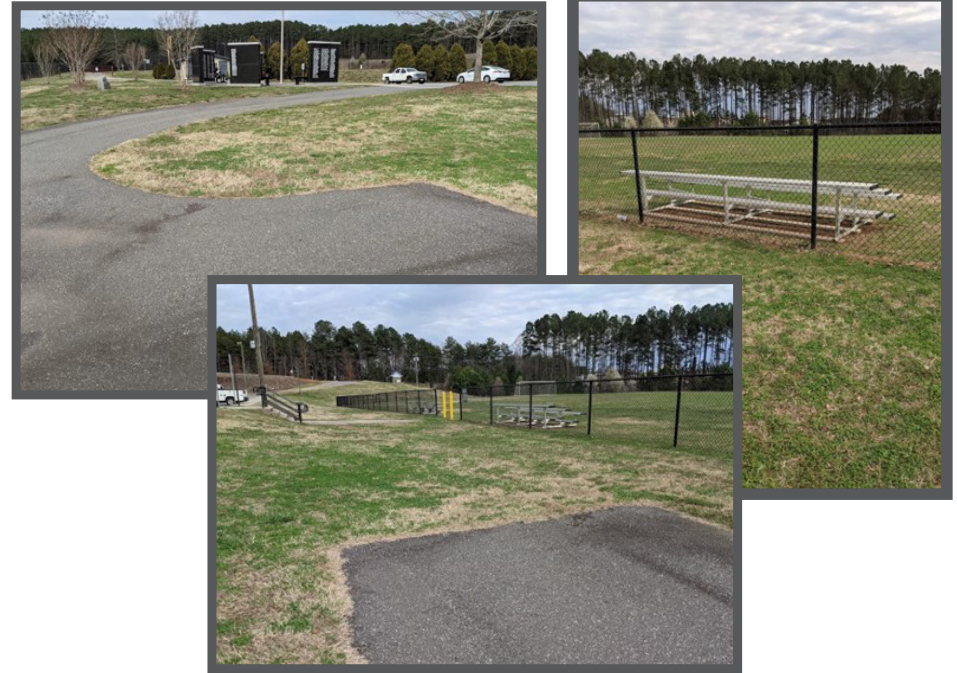
Field 1

- » Field one is not accessible to all users. An accessible path should lead from the parking area to the bleachers with a paved (or other accessible material), level resting area (next to the bleachers) for persons in wheelchairs. Wheelchair spaces cannot overlap circulation paths. The path should also extend to team and player seating. Currently, the path to the bleachers and team seating at field 1 is gravel and not accessible to all users. The fields, however, can remain a grass surface. Please see the sources below for possible accessible path materials.
- » Please see Appendix C.1 for some of the stipulations on ADA playground and accessible route surfaces.
- » Please see Appendix C.2 for multiple ground surfaces to consider in both play grounds and accessible paths.
- » Please see Appendix C.3 for potential ADA compliant surfaces for trails.

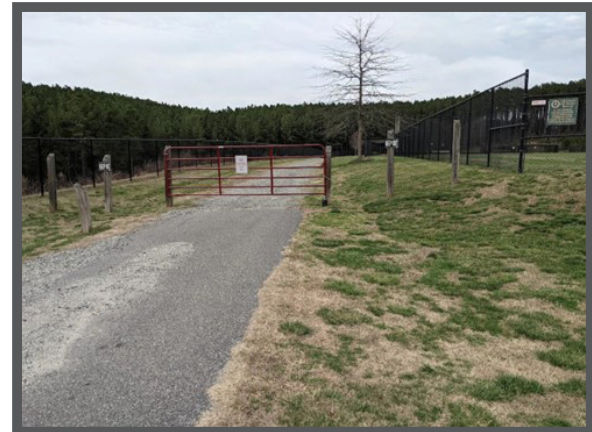
Field 2

- » An accessible path should lead from the parking area to the bleachers with a paved, level resting area (next to the bleachers) for persons in wheelchairs. Wheelchair spaces cannot overlap circulation paths. The path should also extend to team and player seating. Recommend extending the pavement (or other accessible material) to connect to the cement pad at the bleachers and player seating.
- » Currently, there is a fenced off gravel path.
- » Please see links under Field 1 for possible accessible path materials.

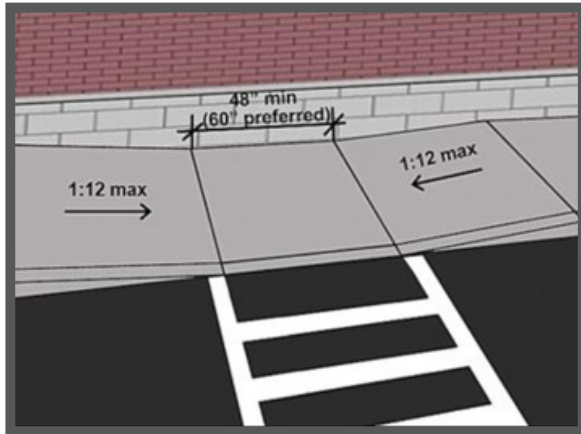
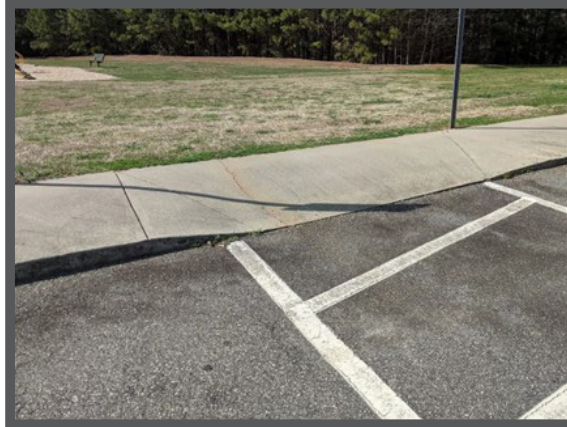
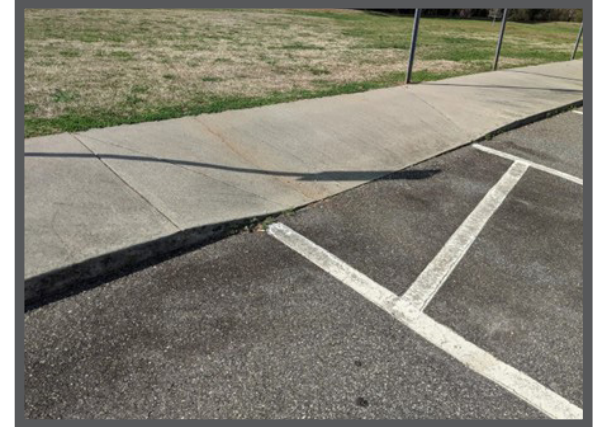
Parking at Lower Veteran's Park

- » The curb ramps at the accessible parking spaces do not follow ADA measurements. The current curb ramps create an unsafe cross slope for all pedestrians. Please see the example below of a parallel curb ramp. The parallel curb ramp is the best fit for the space.

The 6th accessible space (far right) is not signed. Accessible signage must be posted 60" from the ground to the bottom of the sign.

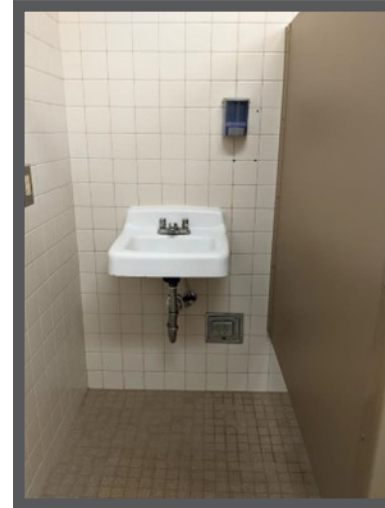
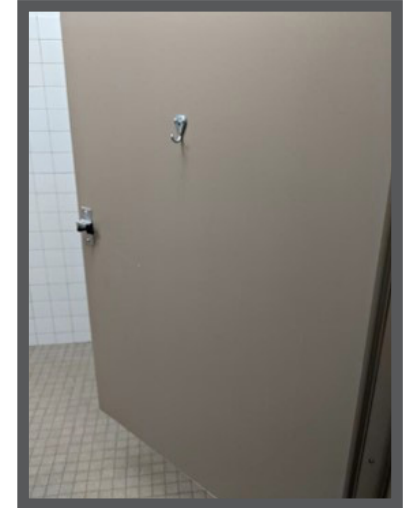
Men's Restroom - Lower Veteran's Park

- » Door Pressures (exterior door leading into facility):
 - » Push Pressure: 13 pounds
 - » Pull Pressure: 15 pounds
 - » Closure Time: 2.91 seconds
- » Pipes aren't insulated below the sink. According to ADA, all pipes must be insulated beneath sinks.
- » When located over sinks, the operable portion of soap dispensers can be no higher than 44". Currently, the soap dispenser is over the sink and 52" high.
- » Coat hooks must be higher than 15 inches and no greater than 48 inches above the floor. Currently, the hook is 52" high.
- » According to ADA, stall doors must be self-closing. Currently, the stall does not self-close.

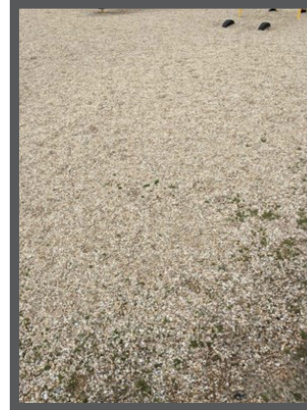
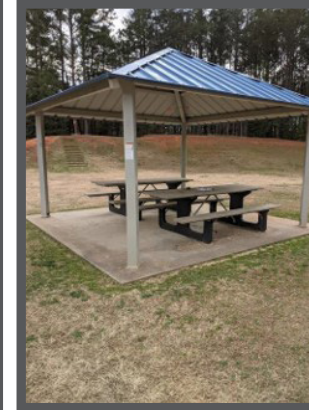
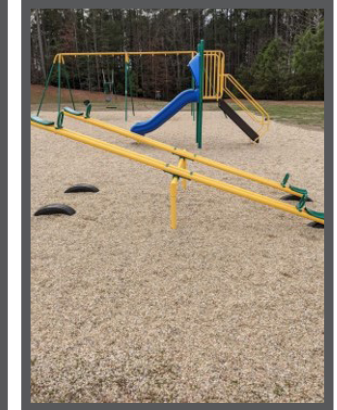
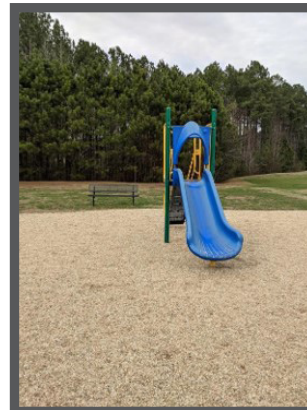
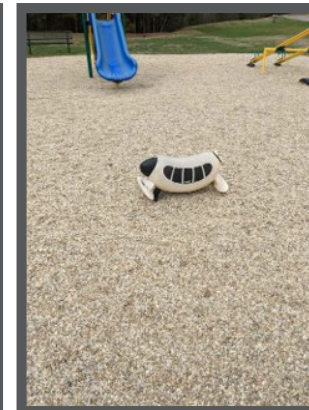
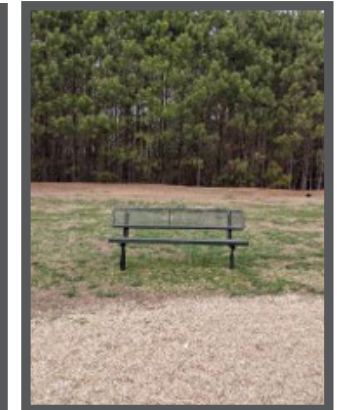
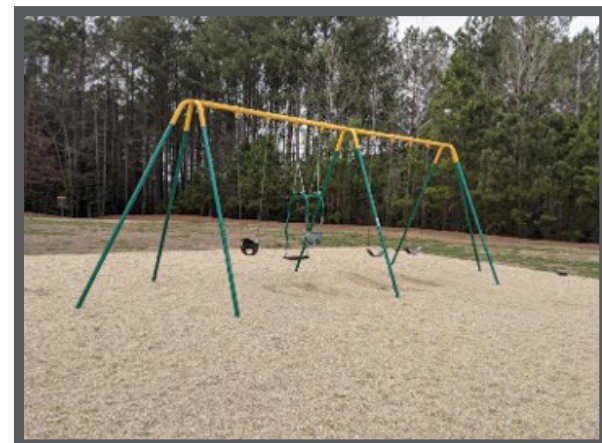
- » The current gravel surface in the playground is not ADA compliant.
 - » Appendix C.1 covers some of the stipulations for ADA playground and accessible route surfaces.
 - » Appendix C.2 covers multiple ground surfaces to consider in both play grounds and accessible paths.
 - » There must be an ADA accessible route to one of each park element. One bench, gazebo, seesaw, slide, bouncer, and swing must connect to the entry/exit of the park. The entry and exit of the park must also connect to the parking area via accessible route. This is the only way persons in wheelchairs (guardians or children) can safely access these elements.

- » Recommendation: There are currently no ADA Standards regulating disc golf. It is, however, recommended that a small portion of holes are accessible to all by means of accessible routes. Accessible routes are continuous, unobstructed paths connecting all accessible elements.
- » Recommendation: Accessible playground equipment is recommended for this park. Currently, there is no inclusive playground equipment.

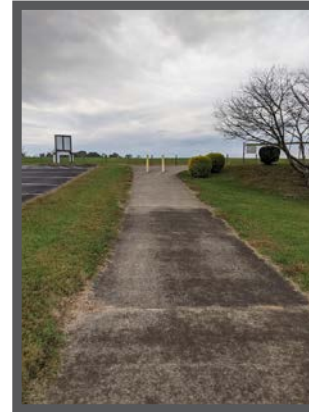
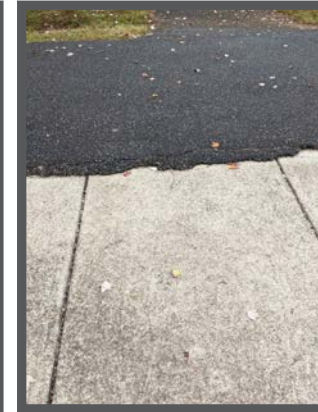
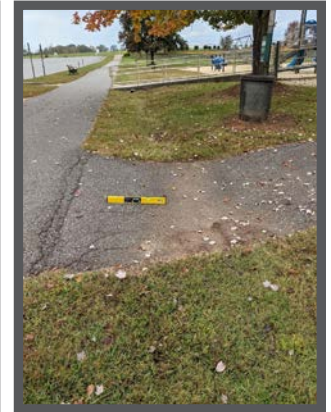
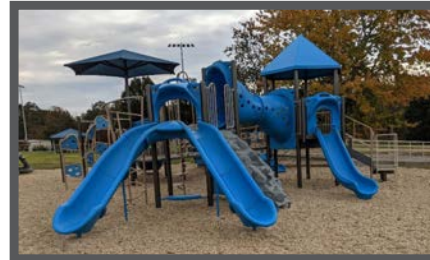
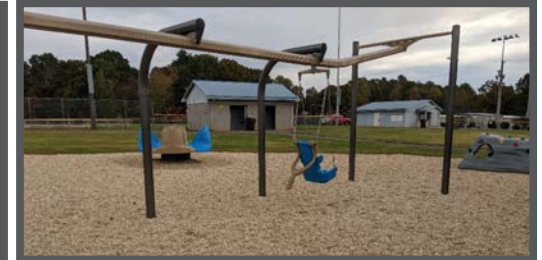
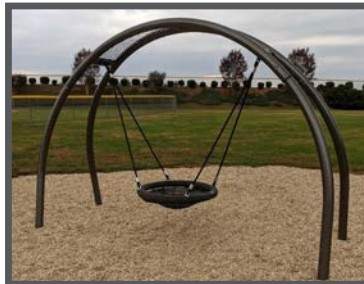
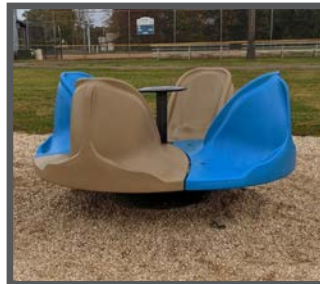
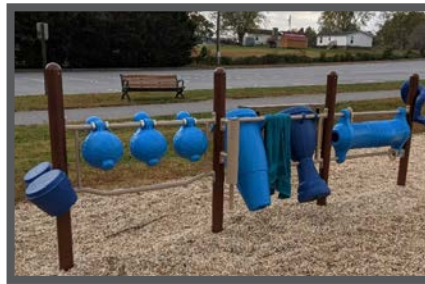
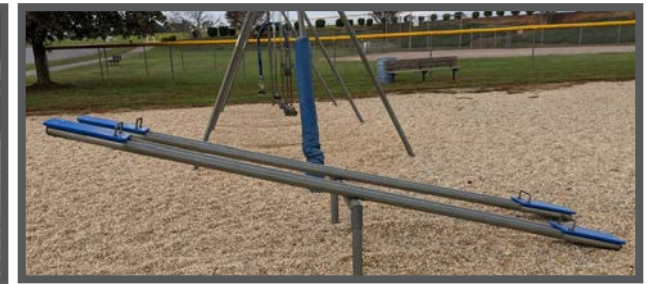
Play Area & Park

- » There is currently a steep dip due to a ditch at the entrance to the park (that leads up to the restrooms). This dip causes a sudden running slope of 10.5% and could be hazardous to those with ambulatory disabilities.

- » Gravel is not an ADA accessible surface. While one of the composite play structures includes an ADA accessible ramp, there should also be accessible exits (i.e. at the bottom of slides and other exit points). One of each play element must be connected by an accessible path to the entrance/exit points of the play area OR the entire surface of the play area must be replaced with an ADA approved surface. Loose material like gravel will not perform adequately unless it is sufficiently stabilized by binders, compaction, or other treatments and will likely require repeated maintenance.

- » An ADA accessible path is necessary to connect the entry and exit points of one composite play structure (i.e. the slides), the drums, zipline, rock wall, one swing, the spinner, and seesaw. This accessible path must also connect to the park entrance/exit.

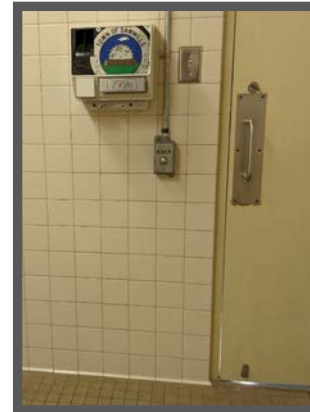
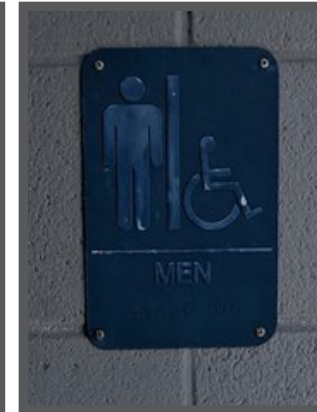
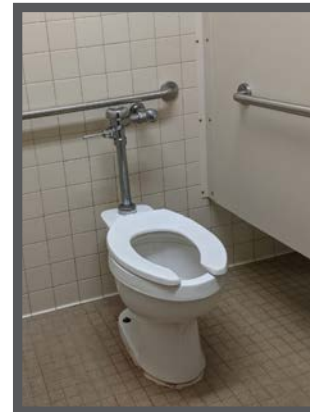
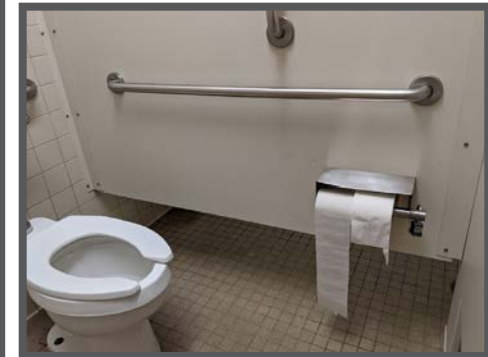
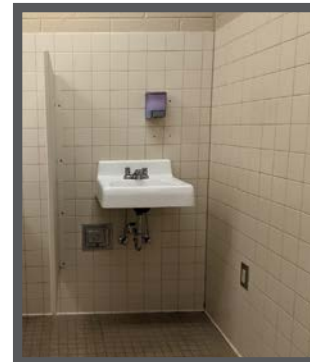
- » The bathroom door is currently very difficult to push open. Generally, ADA Standards require 5 pounds of maximum force for opening doors. There are, however, no standards for exterior doors. The maximum amount of recommended force is 10 pounds with a 5 second closure time.

- » The sink can be difficult to turn on. The force required to activate the faucet can be no greater than 5 pounds.

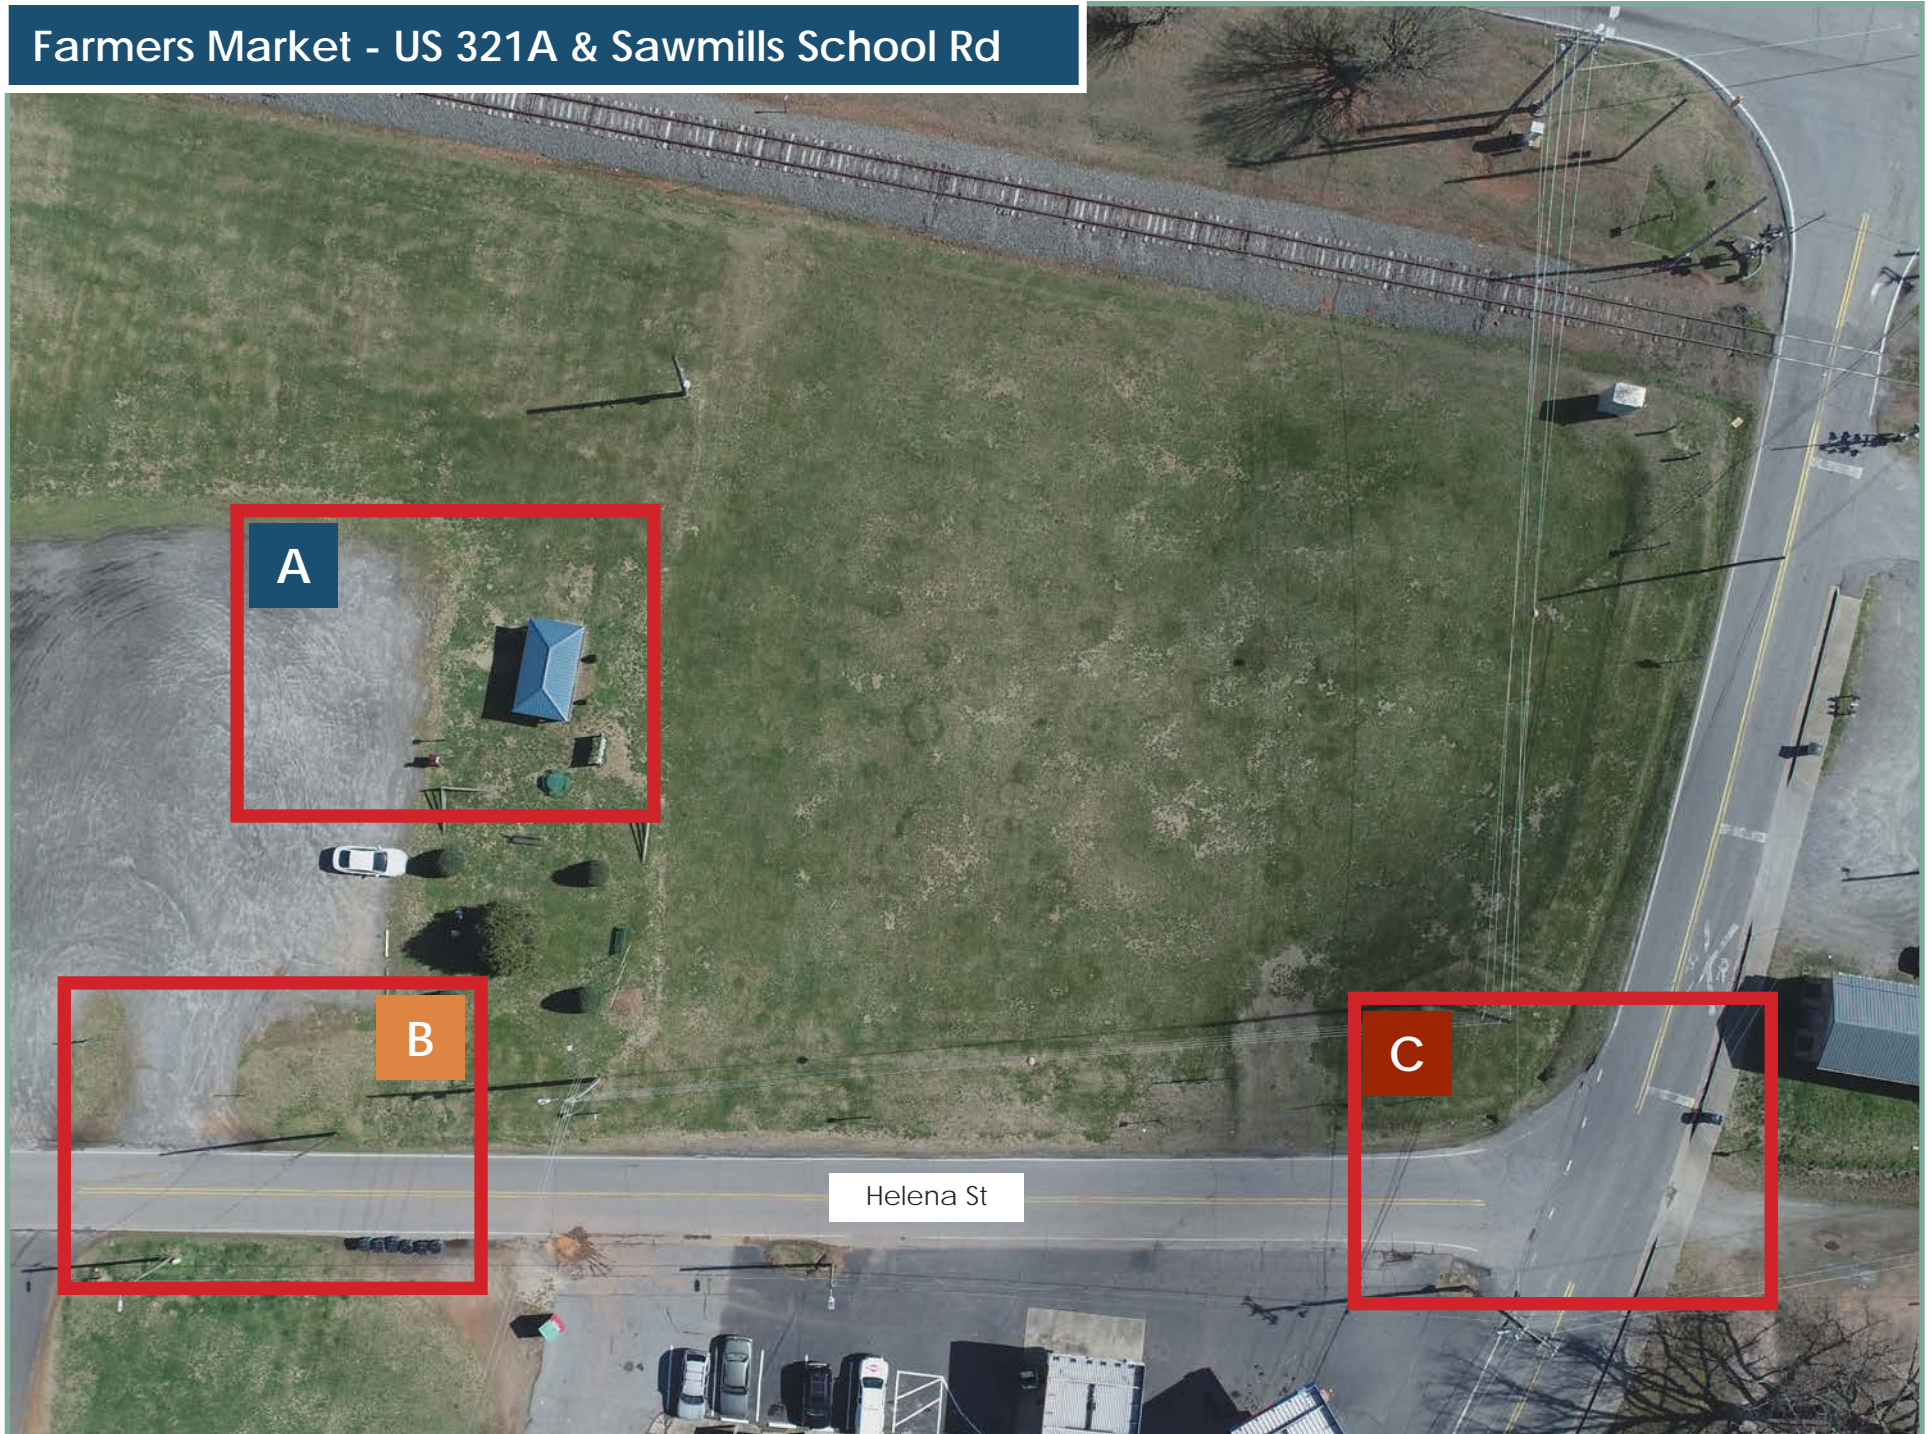
Farmers Market - US 321A & Sawmills School Rd

- » Curb ramps are needed on both sides of Sawmills School Rd at the intersection of Helena St.
- » Detectable warnings are required for curb ramps leading pedestrians into roadways.
