TOWN OF GRANITE FALLS

ADA TRANSITION PLAN

DRAFT - APRIL 2021

Western Piedmont
Council of Governments

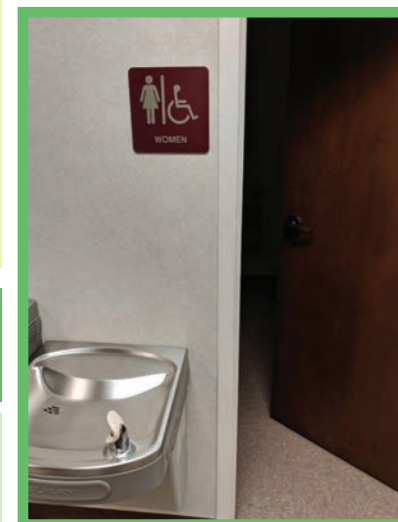
There are 3 inches between the water fountain and the doorway.

- » ADA Standards recommend 18"x18" centered floor space when bathroom door is open 45 degrees. The water fountain is located below sign - if constructed before 3/15/2012 and a person may approach within 3 inches of the sign without encountering protruding objects or standing within the door swing, relocation not required. There are 3 inches between the water fountain and the doorway.
- » No coat hook - coat hooks are not required, however, if coat hook is installed, it must be between 15-48" high.
- » ADA Standards recommend toilet paper dispenser located 7-9" from front of toilet to centerline of dispenser - currently 6" from front of toilet to centerline. This does not apply if the facility was built prior to 3/15/2012.

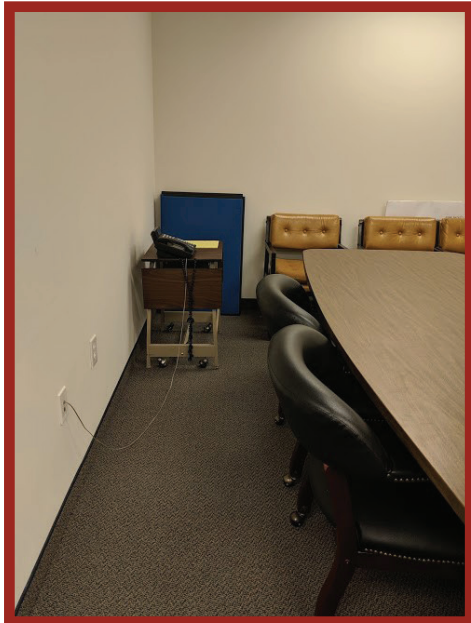
Trip hazard

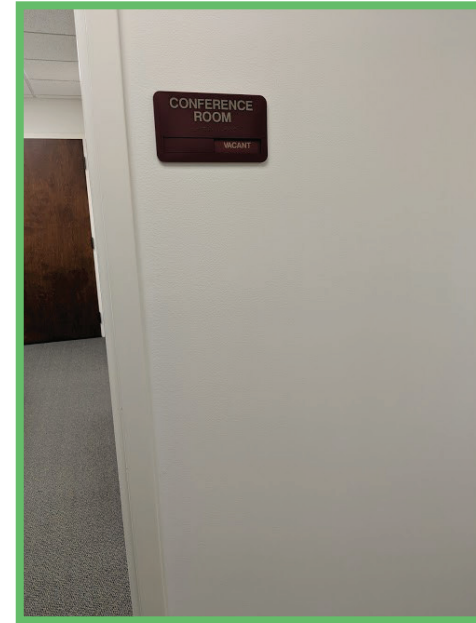
Room signs should be mounted on the wall, on the latch side of the door.

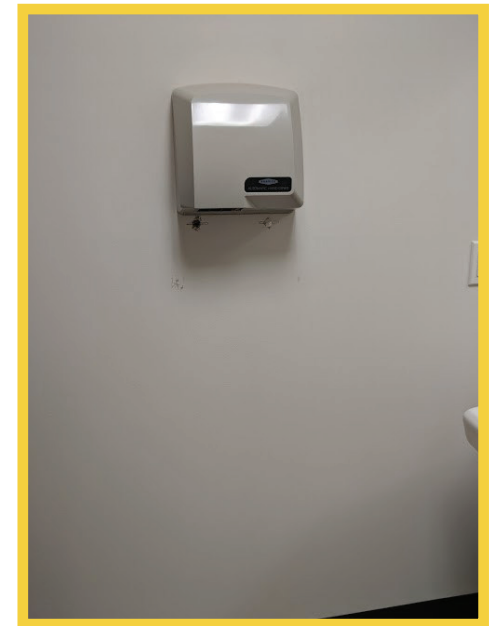
The hand dryer is currently mounted 4.5 inches too high.

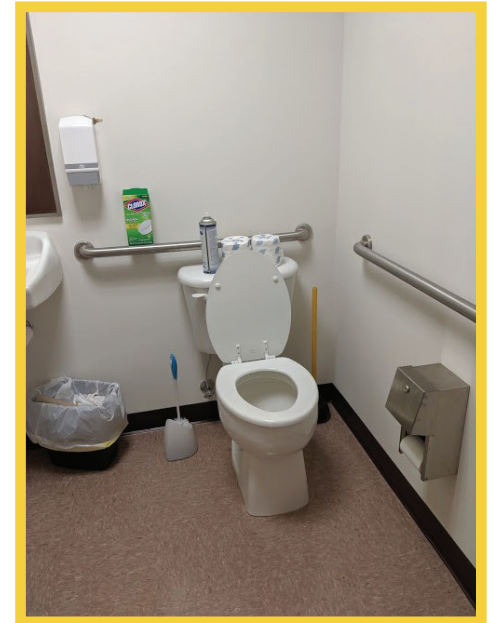
Keep grab bars clear. The toilet paper dispenser is 2 inches below the minimum height.

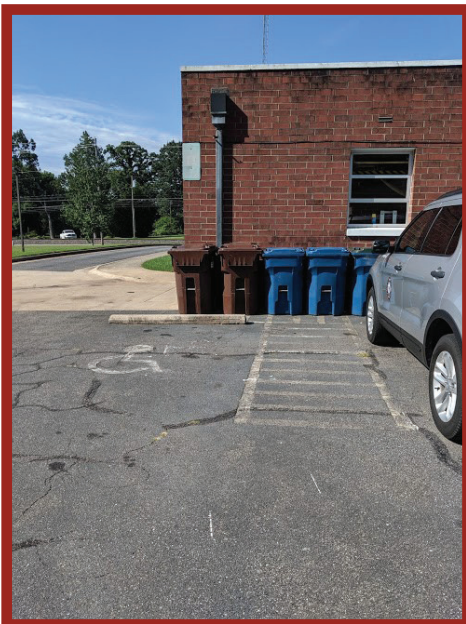
Trash bins cannot block accessible access to the building.

Replace van accessible parking sign to that shown below.

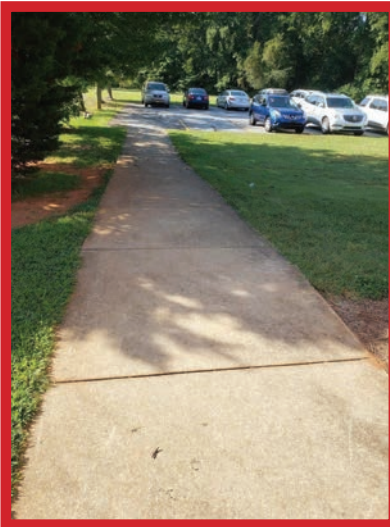
Access routes cannot exceed 2% cross slope.

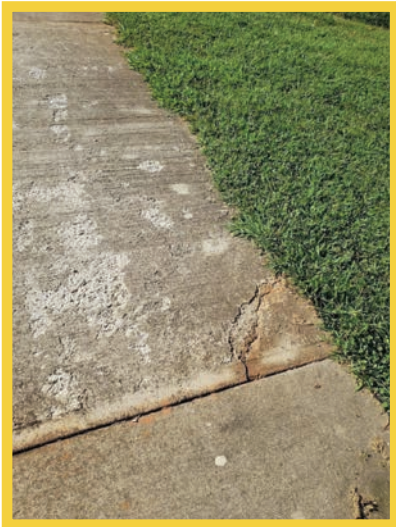
Cracks exceeding 1/2" must be sealed.

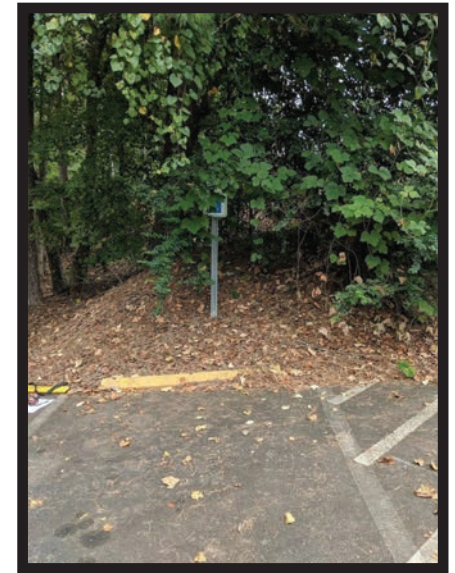
The accessible sign needs to be visible.

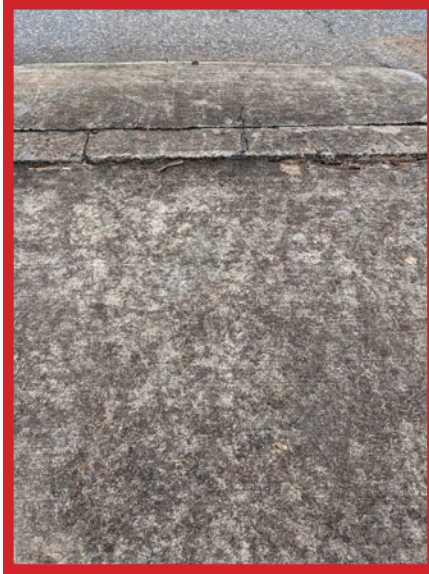
There should be a means for someone wheelchair bound to safely access the play area from Stirling Street. The ramp leading into the park from the road is too steep and not flush with the roadway.

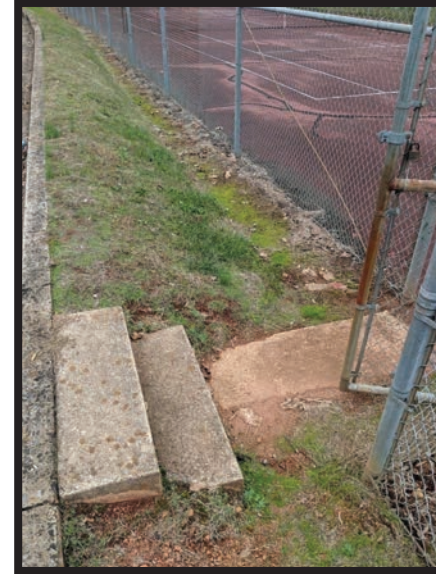
The tennis courts can only be accessed by stairs. The stairs need to be replaced with a ramp that fit the requirements in Priority 1 – Approach and Entrance.

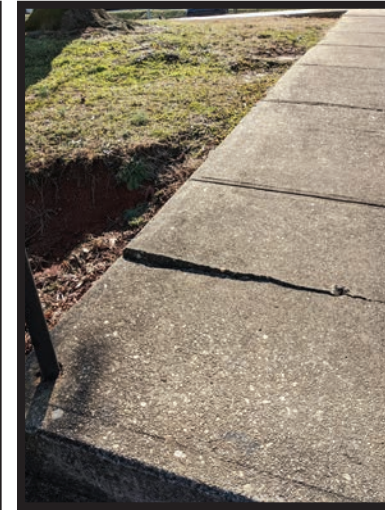
The staircase above is damaged and could pose a trip hazard. There should be signage at the staircase showing those in wheelchairs the accessible route to the play area below.

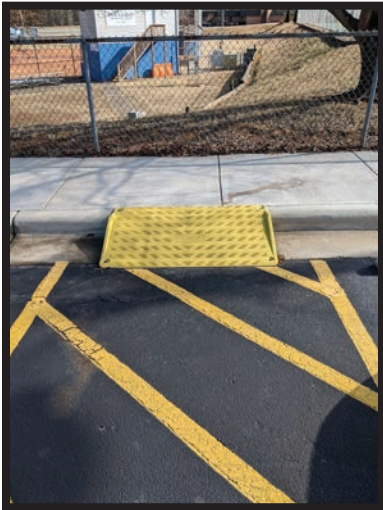
While this ramp offers a temporary fix, it should eventually be replaced with a curb ramp or striping should be rerouted to the existing curb ramp at the restrooms.

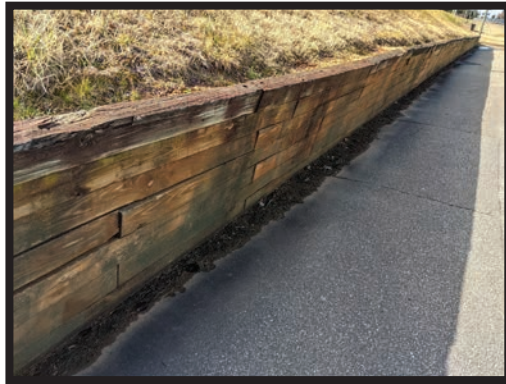
Recommend replacing or reinforcing the leaning retaining wall at the tennis courts. There are no standards enforcing this and is only a recommendation.

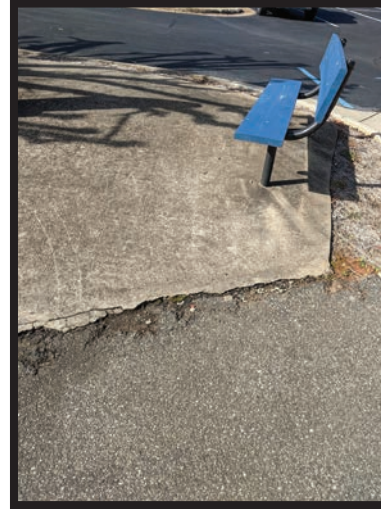
The rest area pictured above has vertical discontinuities that exceed the permitted $\frac{1}{2}$ ".

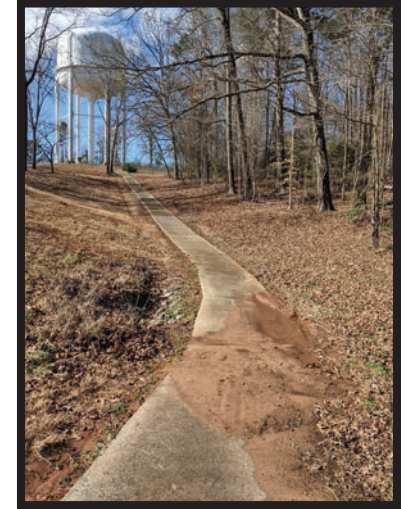
The cross slope is hazardous along certain sidewalk segments next to the storage facility. The cross slope is 11.3 percent in the picture above with drainage issues that could cause a hazardous surface for some users.

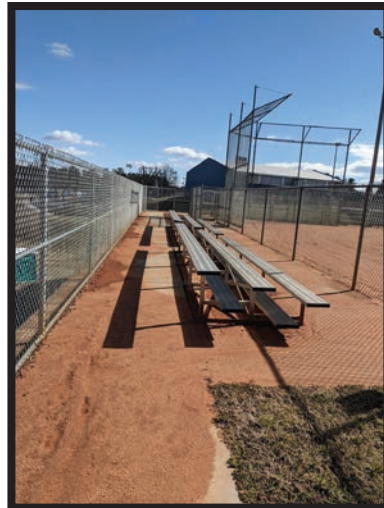
The surface (pictured above) could be hazardous for some users.

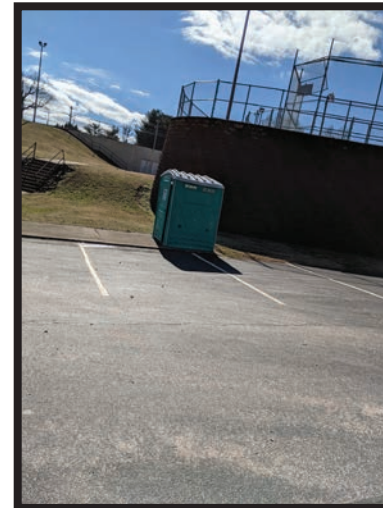
Can visitors access this side of the field from an accessible parking area? If not, one of the spaces pictured above should be designated an accessible space.

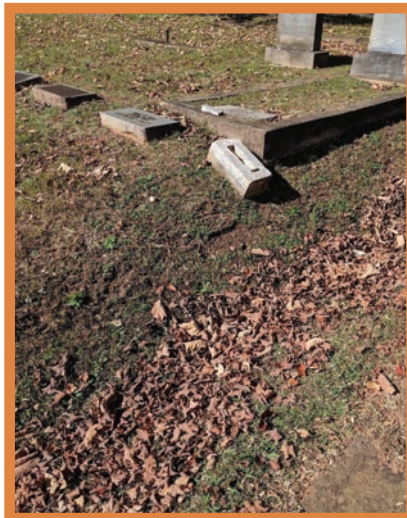
Drainage issue could cause trip hazard.

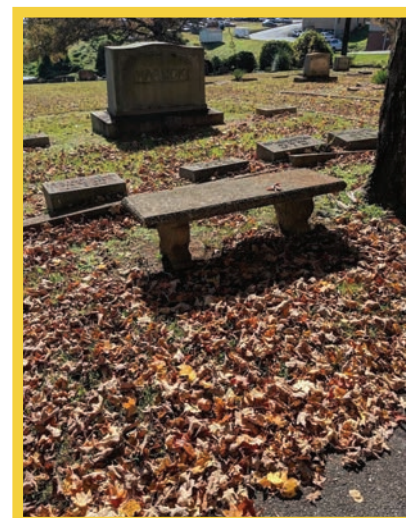
Public benches should have a paved and level resting area.
