Sawmills

ADA Transition Plan

Adopted on November 19, 2024

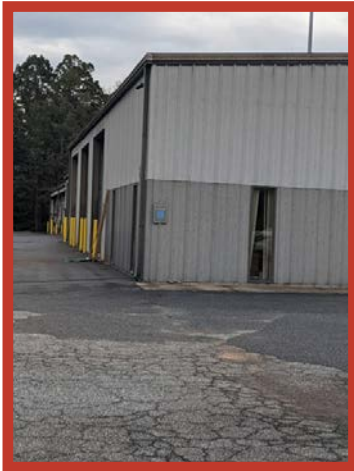
Need designated accessible parking with signage and striped access.

High Priority	Moderate Priority	Low Priority
<ul style="list-style-type: none"> » Accessible parking space must have a designated space and striped access aisle. » A new accessible parking space sign is needed. The sign must be posted 60" high to the base and must be marked van accessible. 	» n/a	» n/a
Technically Infeasible or Not Applicable (due to changing standards or measurements within tolerance range)		Currently, there are no High, Moderate or Low Recommendations
» n/a

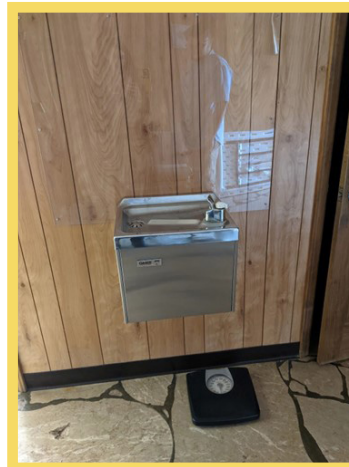
High Priority	Moderate Priority	Low Priority
» n/a	» n/a	» The water fountain does not currently meet the 2010 ADA Standards for Accessible Design. Please follow Priority 4 - Additional Access in the Appendix when making changes to lower priority structures such as water fountains. (Appendix A)
Technically Infeasible or Not Applicable (due to changing standards or measurements within tolerance range)		Currently, there are no High, Moderate or Low Recommendations
» n/a

Fountain does not meet current design standards.

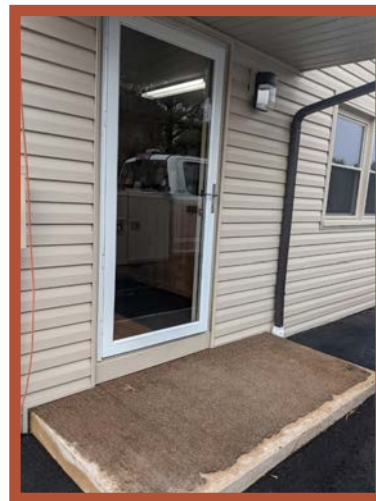
High Priority	Moderate Priority	Low Priority
<ul style="list-style-type: none">» Currently there is no designated accessible parking» The entrance must be flush with the doorway to allow access for all users	» n/a	» n/a
Technically Infeasible or Not Applicable (due to changing standards or measurements within tolerance range)		Currently, there are no High, Moderate or Low Recommendations
» n/a

Entrance should be flush

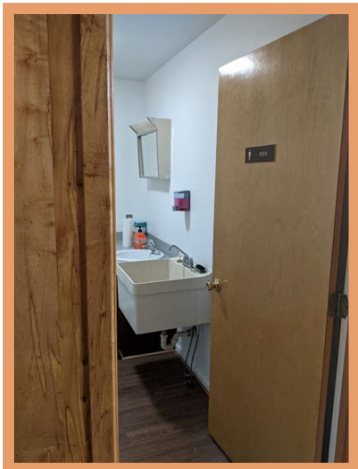
High Priority	Moderate Priority	Low Priority
<ul style="list-style-type: none"> » Compartment around toilet only 28" wide – ADA Standards require an open side of the toilet where the flush handle is located. Toilet compartments must measure 60" wide and 56" deep. There is currently not enough clearance around the toilet. <ul style="list-style-type: none"> » There must also be at least 48" for a forward approach to the sink. There is currently only 45" between the toilet and the sink. 	<ul style="list-style-type: none"> » Signage for the restroom should be in Braille and mounted on the latch side of the door at the heights designated in Appendix A Priority 3 – Toilet Rooms » There is not sufficient knee space for the sink – ADA Standards require at least 27" clearance from the floor to the bottom of the sink that extends at least 8" under the sink for knee clearance. 	<ul style="list-style-type: none"> » 48" tall soap dispenser over utility sink – If above a sink or countertop between 20-25" deep, the soap dispenser cannot be higher than 44" above the floor. <ul style="list-style-type: none"> » A soap dispenser can only be mounted 48" high when the sink/counter is less than 20" deep.

Signage should be in braille and mounted on latch side of door

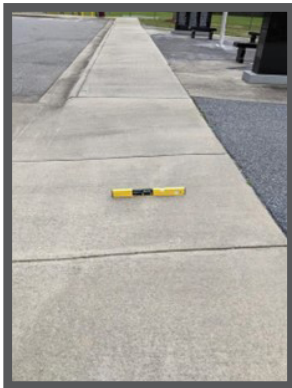
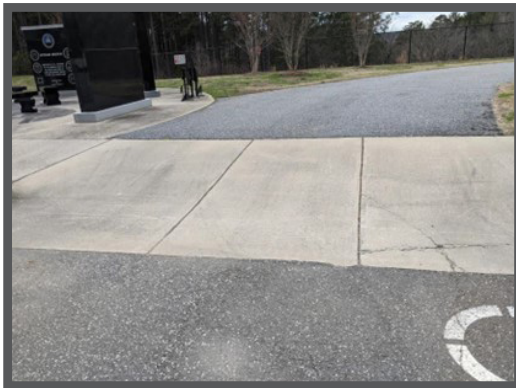
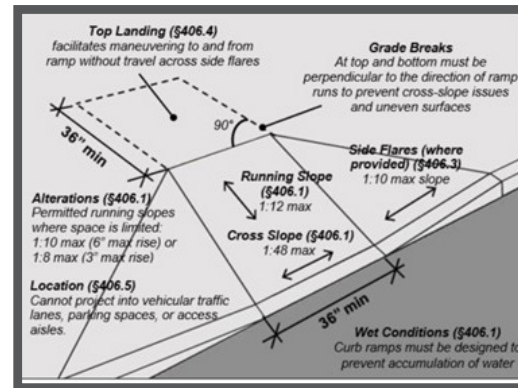
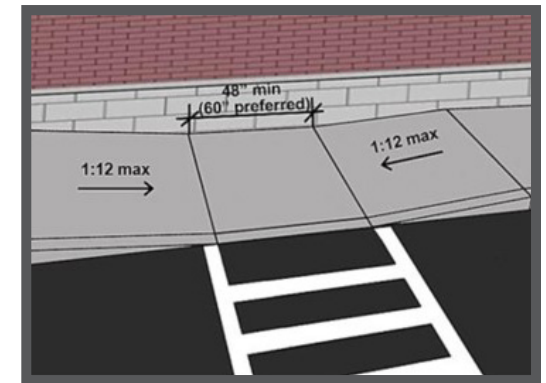
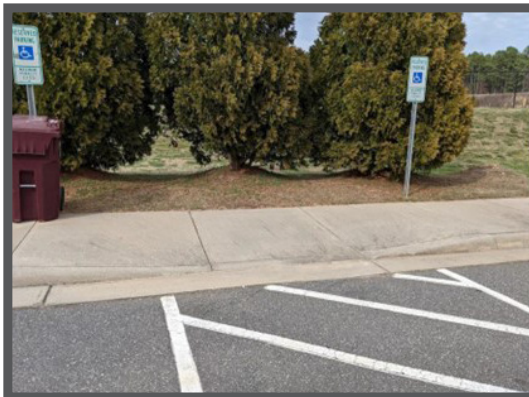
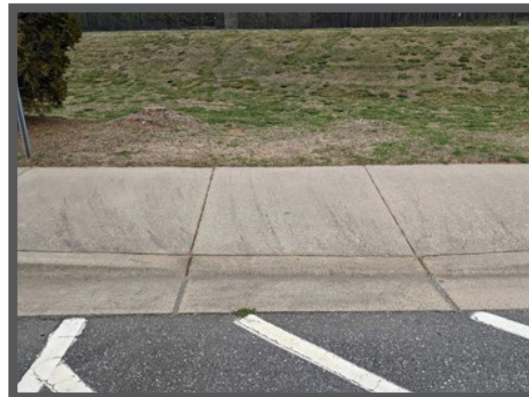
- » Driveway cuts that cross pedestrian routes must have a 2% or less cross slope.
- » The curb ramps at the accessible spaces (closest to the restrooms) have no level landing and creates a 5% cross slope for pedestrians using the sidewalk. Example curb ramp types are shown below. The first example shows a top landing that prevents pedestrian hazards when crossed. The second example shows parallel curb ramps used for confined spaces. The limited slope and flat landing prevents pedestrian hazards.

The curb ramp closest to the soccer field has a top landing right next to the stairs. Recommend high-viz striped tape on the stairs as well as directional signage showing the nearest accessible route. (high recommendation)

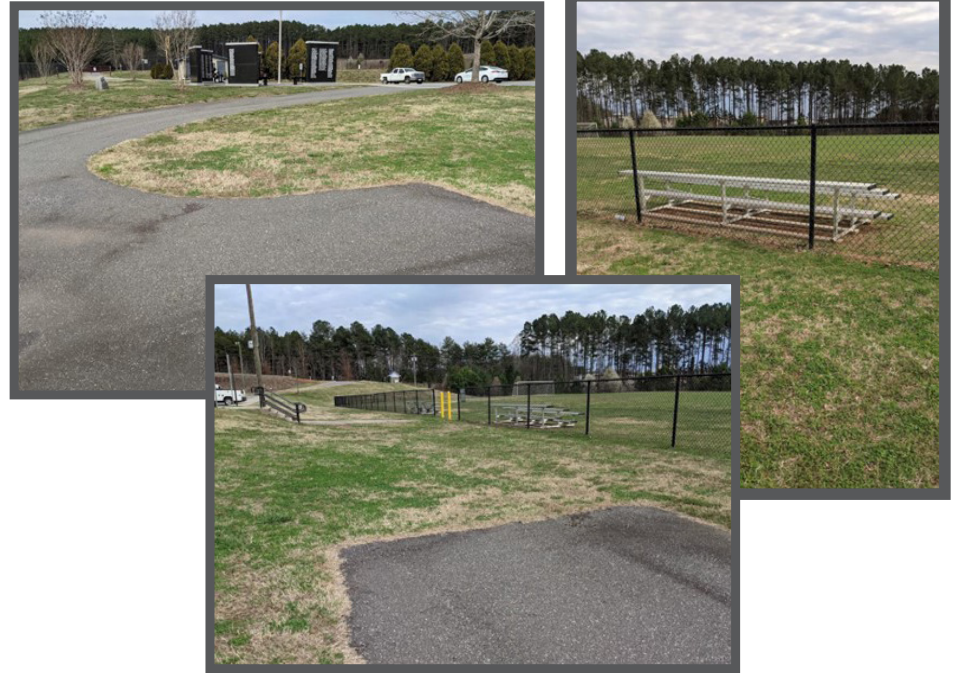
Field 1

- » Field one is not accessible to all users. An accessible path should lead from the parking area to the bleachers with a paved (or other accessible material), level resting area (next to the bleachers) for persons in wheelchairs. Wheelchair spaces cannot overlap circulation paths. The path should also extend to team and player seating. Currently, the path to the bleachers and team seating at field 1 is gravel and not accessible to all users. The fields, however, can remain a grass surface. Please see the sources below for possible accessible path materials.
- » Please see Appendix C.1 for some of the stipulations on ADA playground and accessible route surfaces.
- » Please see Appendix C.2 for multiple ground surfaces to consider in both play grounds and accessible paths.
- » Please see Appendix C.3 for potential ADA compliant surfaces for trails.

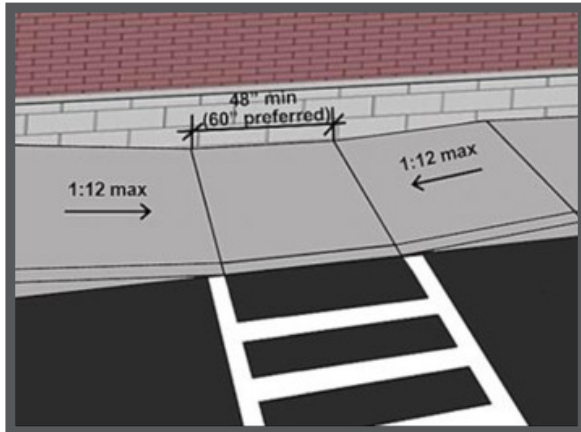
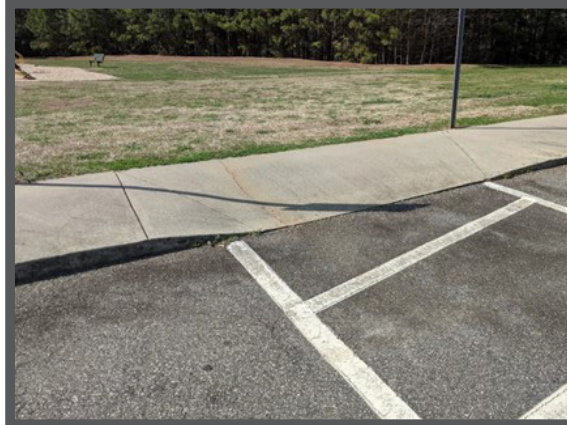
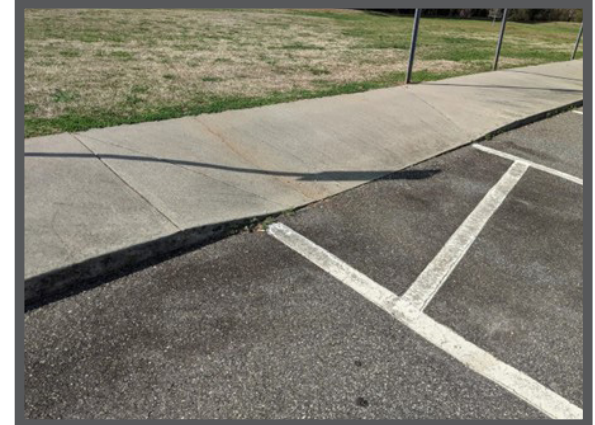
Parking at Lower Veteran's Park

- » The curb ramps at the accessible parking spaces do not follow ADA measurements. The current curb ramps create an unsafe cross slope for all pedestrians. Please see the example below of a parallel curb ramp. The parallel curb ramp is the best fit for the space.

The 6th accessible space (far right) is not signed. Accessible signage must be posted 60" from the ground to the bottom of the sign.

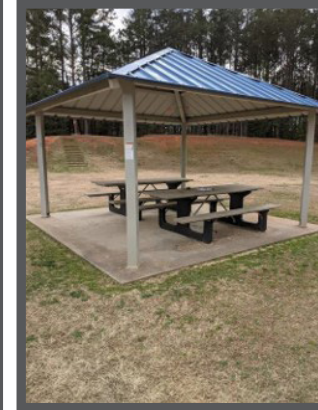
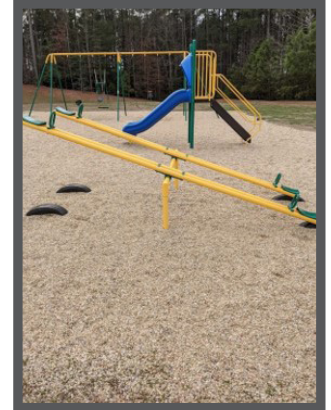
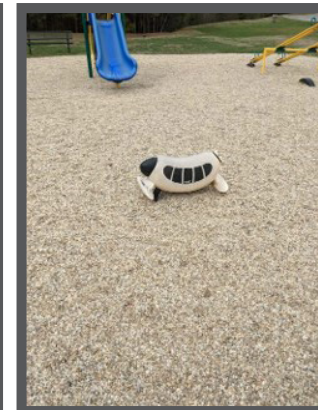
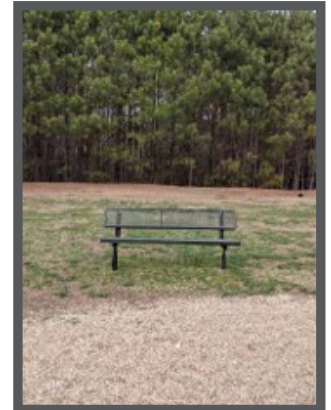
- » The current gravel surface in the playground is not ADA compliant.
 - » Appendix C.1 covers some of the stipulations for ADA playground and accessible route surfaces.
 - » Appendix C.2 covers multiple ground surfaces to consider in both play grounds and accessible paths.
 - » There must be an ADA accessible route to one of each park element. One bench, gazebo, seesaw, slide, bouncer, and swing must connect to the entry/exit of the park. The entry and exit of the park must also connect to the parking area via accessible route. This is the only way persons in wheelchairs (guardians or children) can safely access these elements.

- » Recommendation: There are currently no ADA Standards regulating disc golf. It is, however, recommended that a small portion of holes are accessible to all by means of accessible routes. Accessible routes are continuous, unobstructed paths connecting all accessible elements.
- » Recommendation: Accessible playground equipment is recommended for this park. Currently, there is no inclusive playground equipment.

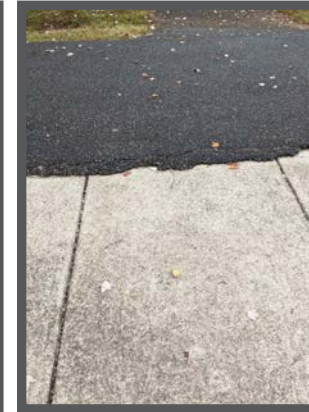
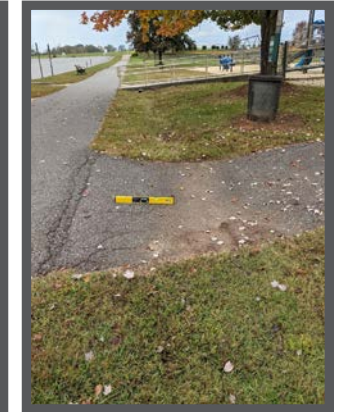
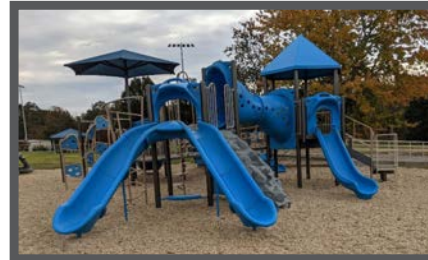
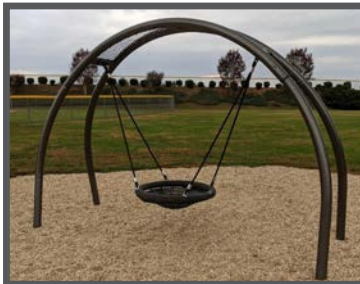
- » There is currently a steep dip due to a ditch at the entrance to the park (that leads up to the restrooms). This dip causes a sudden running slope of 10.5% and could be hazardous to those with ambulatory disabilities.

- » Gravel is not an ADA accessible surface. While one of the composite play structures includes an ADA accessible ramp, there should also be accessible exits (i.e. at the bottom of slides and other exit points). One of each play element must be connected by an accessible path to the entrance/exit points of the play area OR the entire surface of the play area must be replaced with an ADA approved surface. Loose material like gravel will not perform adequately unless it is sufficiently stabilized by binders, compaction, or other treatments and will likely require repeated maintenance.

- » An ADA accessible path is necessary to connect the entry and exit points of one composite play structure (i.e. the slides), the drums, zipline, rock wall, one swing, the spinner, and seesaw. This accessible path must also connect to the park entrance/exit.
