Sawmills

ADA Transition Plan

This report will identify barriers within municipally owned buildings as well as barriers within the pedestrian right of way. The pedestrian right of way includes any infrastructure meant for pedestrian utilization. Mobility hazards are identified during walking audits and documented in a Pedestrian Right of Way Collector Application. The application collects a broad range of data and has criteria for sidewalks, curb ramps, driveway cuts, intersections, railroad crossings, bus stops, crosswalks, and pedestrian islands.

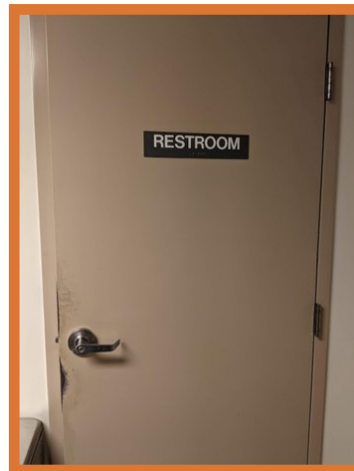
Signage should be in Braille and mounted on the latch side of the door at regulation height.

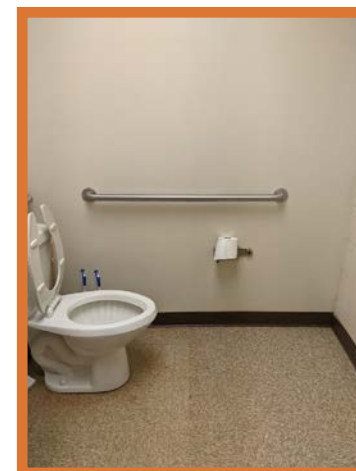
Toilet paper dispenser needs to be closer to the toilet.

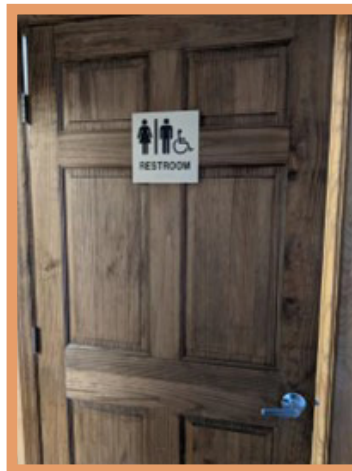
Accessible restroom signage should be placed on the latch side of the doorway.

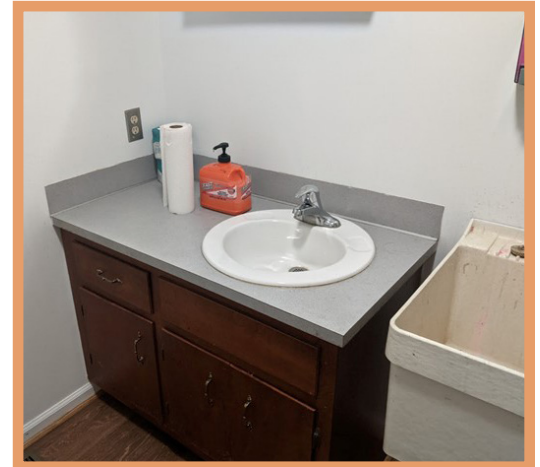
Not enough knee space under the sink
