TOWN OF GRANITE FALLS

ADA TRANSITION PLAN

DRAFT - APRIL 2021

Western Piedmont
Council of Governments

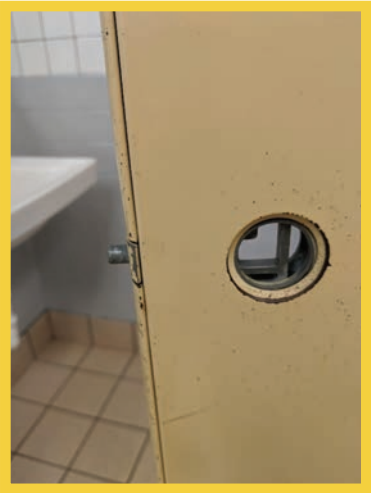
Recommend replacing damaged lock.

» Repair damaged stall door locks.

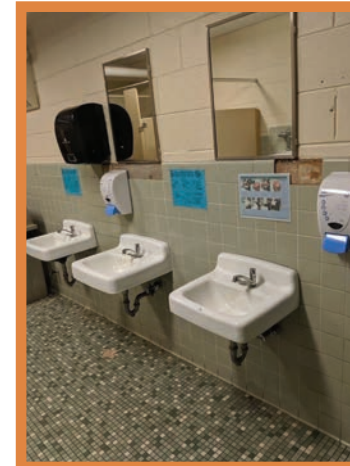
Insulate pipes under sinks and lower mirrors.

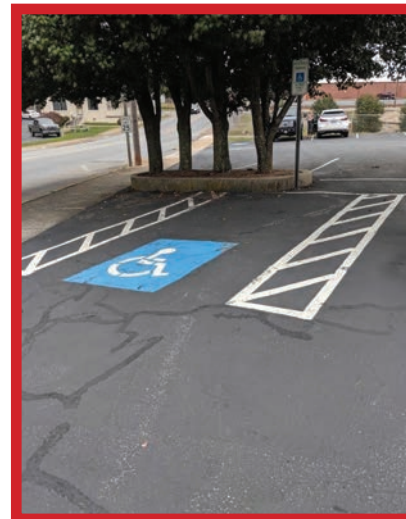
Access aisle needs to be 5 ft. wide.

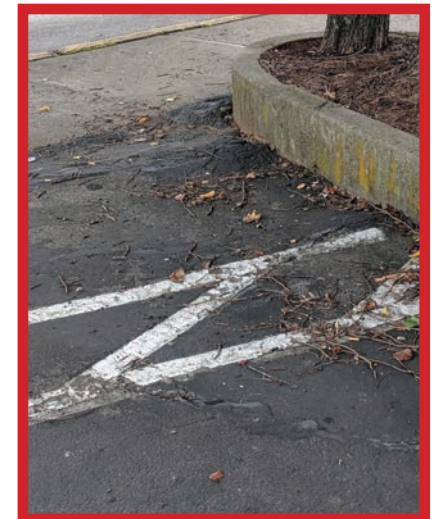
Access aisle is unlevel.

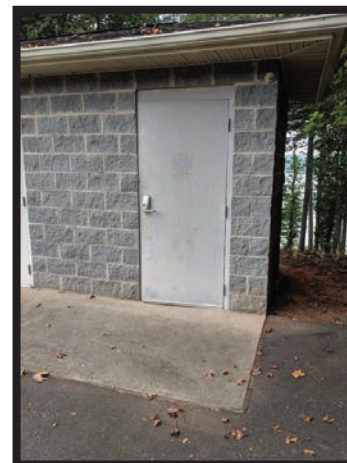
Restroom signage must include braille.

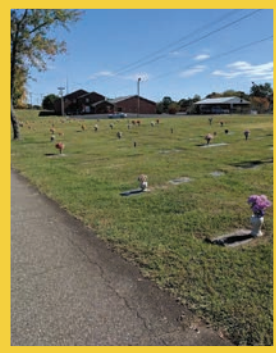
Future plots are recommended to be a minimum of 10 ft from the road and 20 ft from boundaries and fences

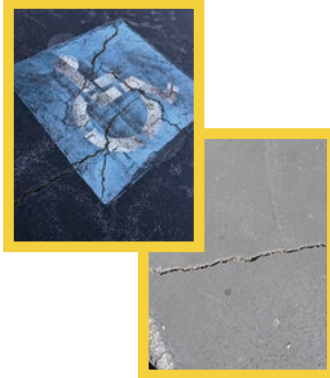
Seal cracks exceeding 1/2 inch.

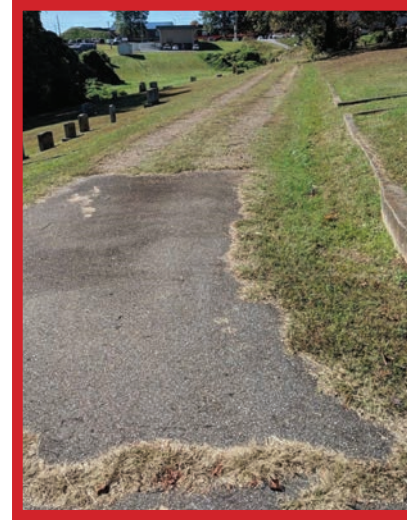
Main roadways should be paved.
