Sawmills

ADA Transition Plan

Adopted on November 19, 2024

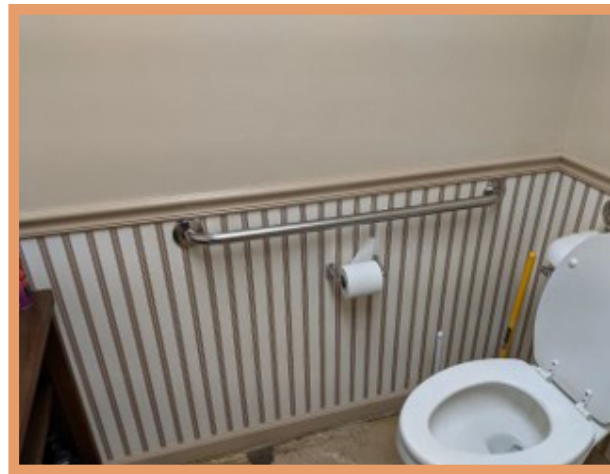
Side bar grab needs to meet designated requirements.

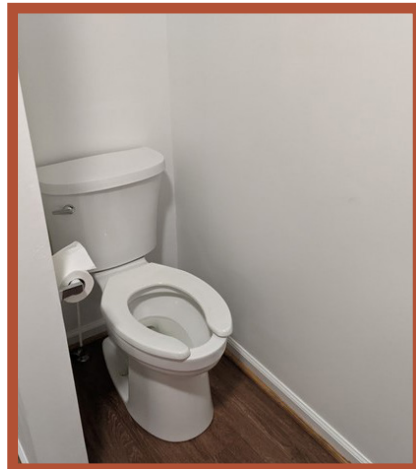
There is currently not enough clearance around the toilet

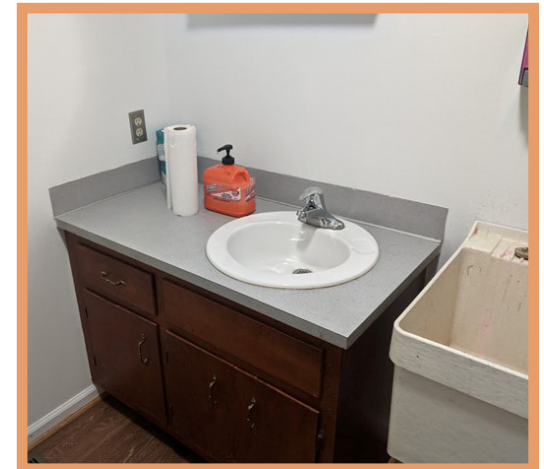
Not enough knee space under the sink
