Sawmills

ADA Transition Plan

This report will identify barriers within municipally owned buildings as well as barriers within the pedestrian right of way. The pedestrian right of way includes any infrastructure meant for pedestrian utilization. Mobility hazards are identified during walking audits and documented in a Pedestrian Right of Way Collector Application. The application collects a broad range of data and has criteria for sidewalks, curb ramps, driveway cuts, intersections, railroad crossings, bus stops, crosswalks, and pedestrian islands.

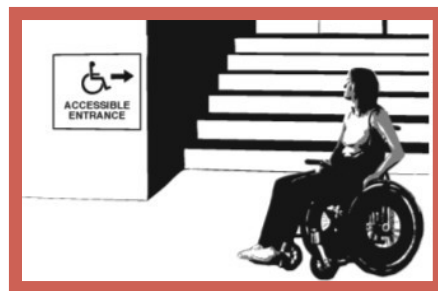
Inaccessible entrances must have signage for the nearest accessible entrance.

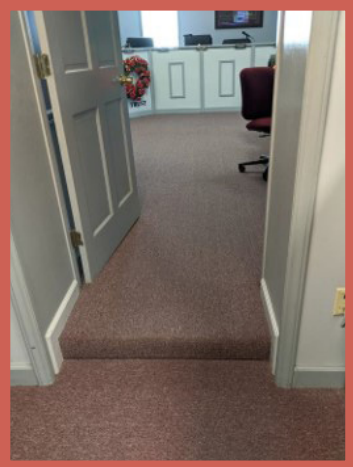
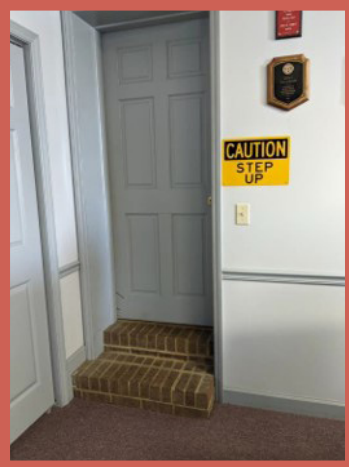
Public bathroom is not accessible due to steps and narrow doorways

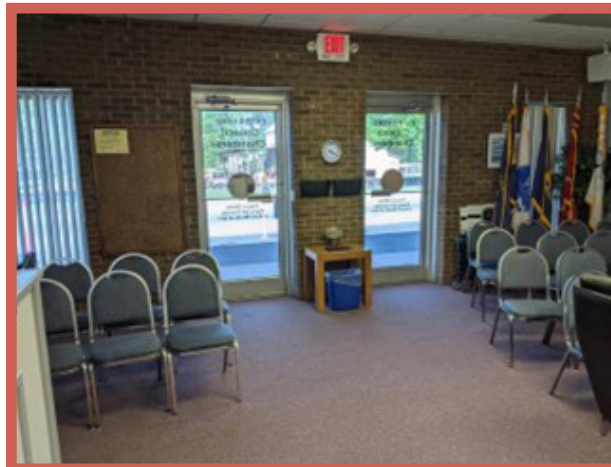
Wheelchair resting areas must be provided within council chambers.

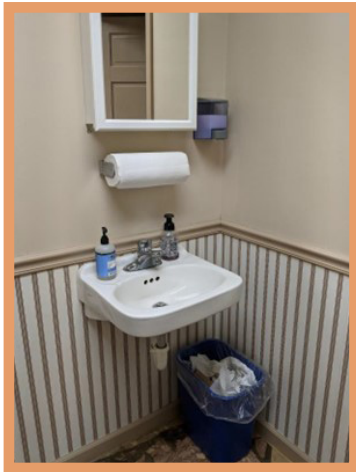
| High Priority | Moderate Priority | Low Priority |
|---|---|---|
| <ul style="list-style-type: none"> » n/a | <ul style="list-style-type: none"> » When a mirror is mounted above a sink, the bottom edge of the reflecting surface must be no higher than 40". Currently, the bottom edge of the reflecting surface is 52" above the floor. » Pipes below the sink must be fully insulated or configured to protect against contact. Currently, the pipes below the sink are only partially insulated. » Side grab bars above toilets must be at least 42" long on the side wall. It must be located no more than 12" from the rear wall and extend at least 54" from the rear wall. The grab bar must be mounted between 33" and 36" above the floor. The current side grab bar is only 36" long. » The rear grab bar must be at least 36" long on the rear wall. The current rear grab bar is only 18" long. | <ul style="list-style-type: none"> » The soap dispenser mounted on the wall next to the sink is not currently utilized. If utilized, the dispenser should be moved no higher than 48" above the floor. The current dispenser is 51" above the floor. » The towel dispenser is currently 48" above the floor and mounted over the sink. When over sinks or counters less than 20" and no greater than 25" deep, towel dispensers must not be 44" above the floor. |

Lower mirror.

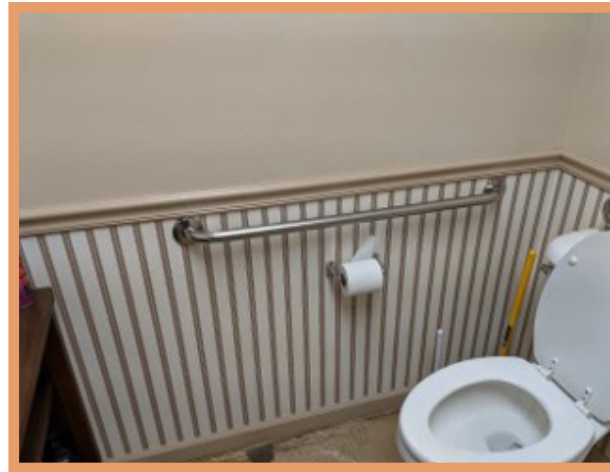
Side bar grab needs to meet designated requirements.

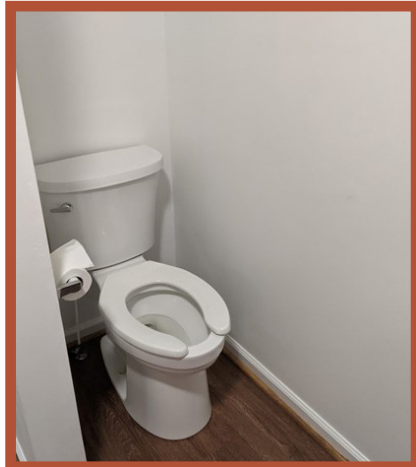
There is currently not enough clearance around the toilet

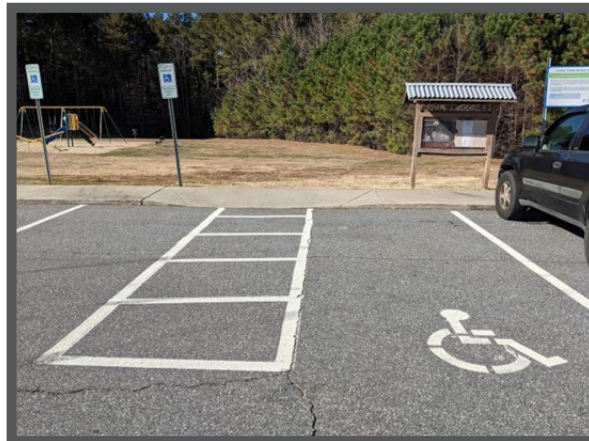
Parking at Lower Veteran's Park

The 6th accessible space (far right) is not signed. Accessible signage must be posted 60" from the ground to the bottom of the sign.

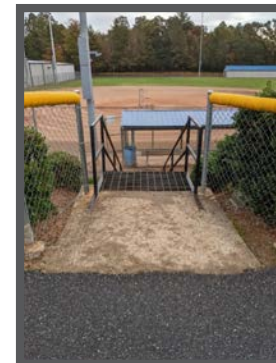
- » Recommendation: Include yellow reflective tape on steep staircases.

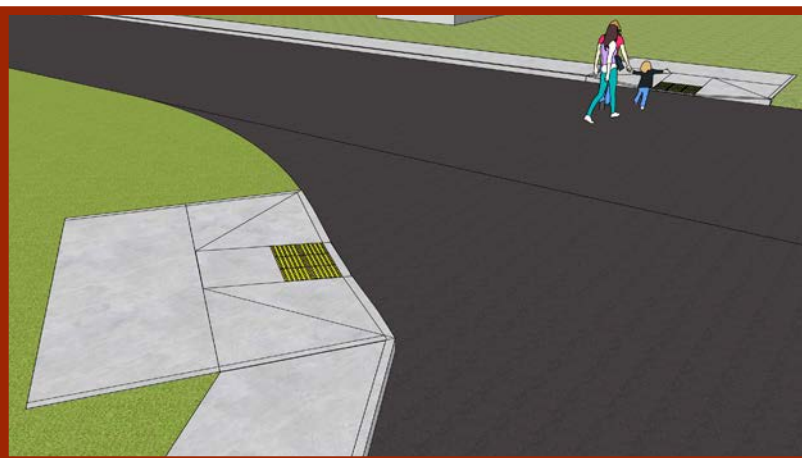
C

- » Curb ramps are needed on both sides of Sawmills School Rd at the intersection of Helena St.
- » Detectable warnings are required for curb ramps leading pedestrians into roadways.

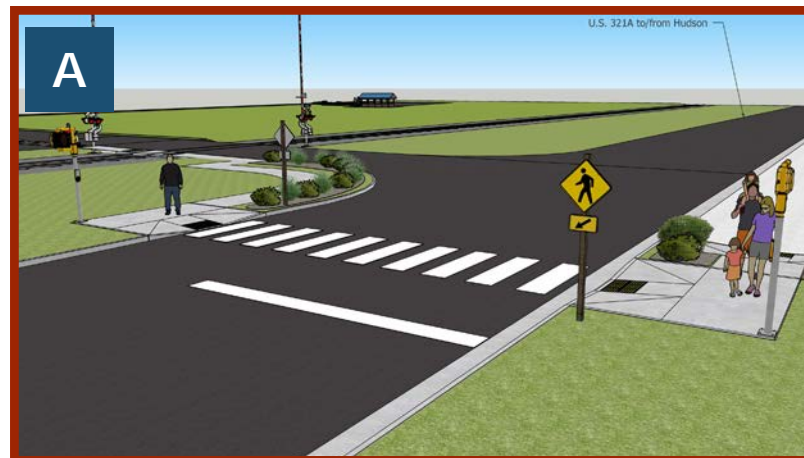
US 321A & Sawmills School Rd

A » High visual crosswalk with compliant curb ramps, detectable warnings, and pedestrian signals are needed at both ends of crosswalk.

B » The pedestrian path must be at least 4 feet wide for the entire crossing. The surface between and on either side of the rails must be aligned with the top of the rails.

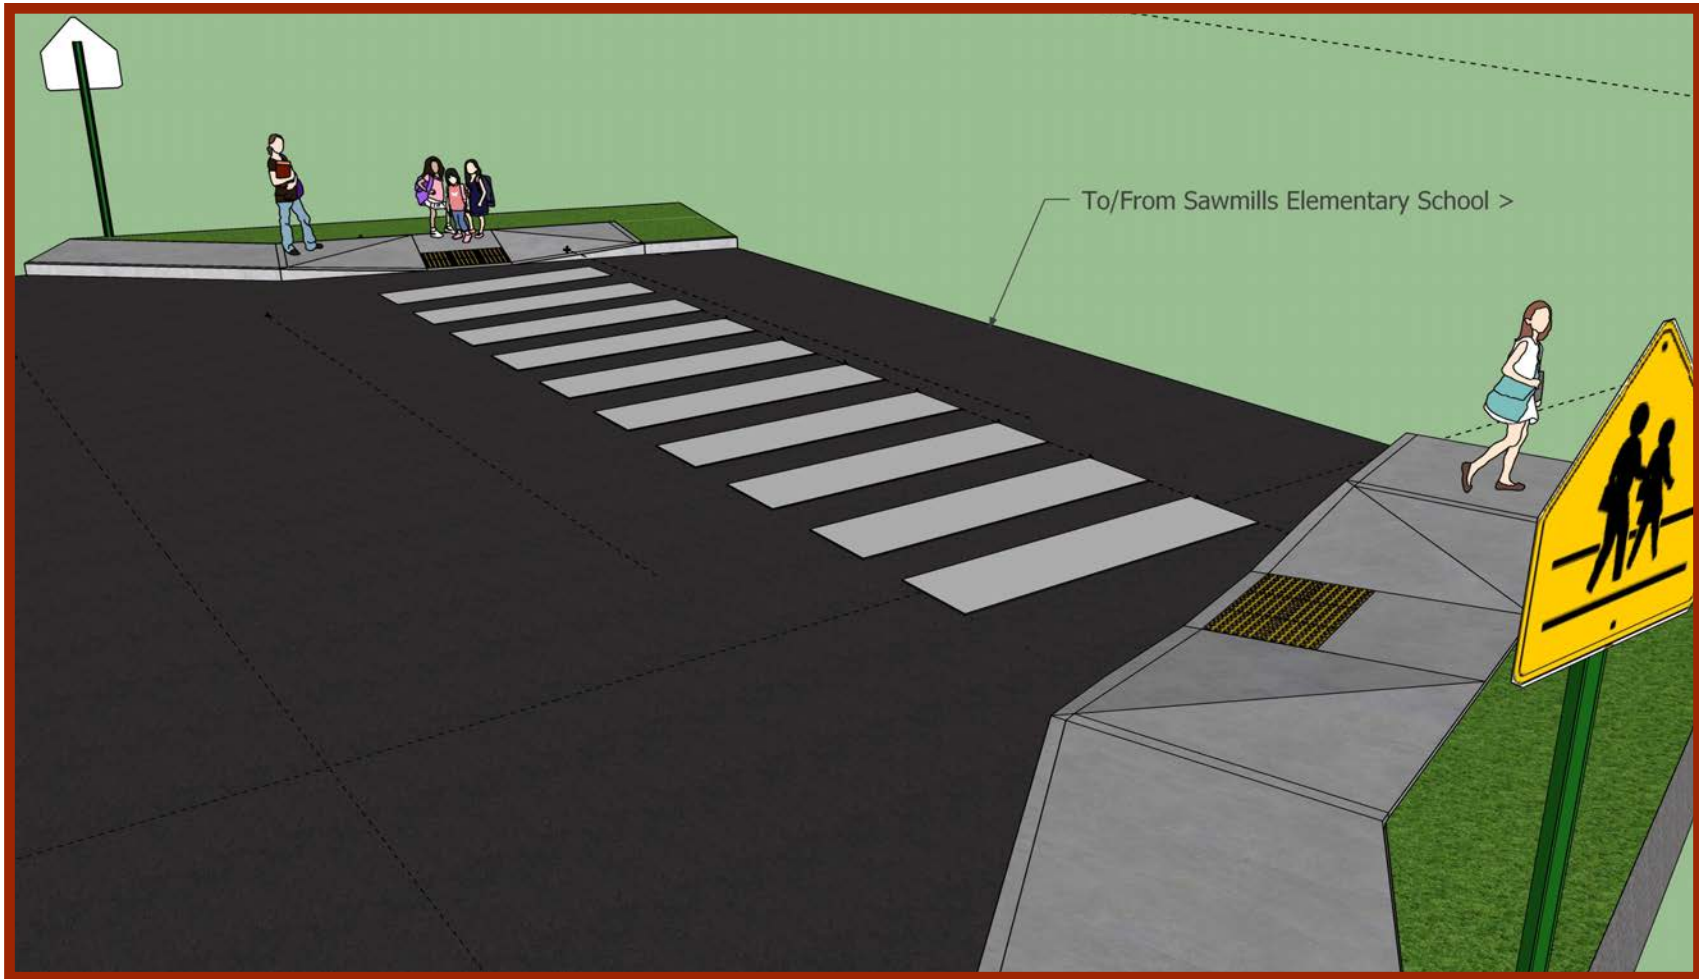
Sawmills Elementary School Entrance

- A » High visual crosswalk with compliant curb ramps, detectable warnings, and pedestrian signage are needed at both ends of crosswalk.

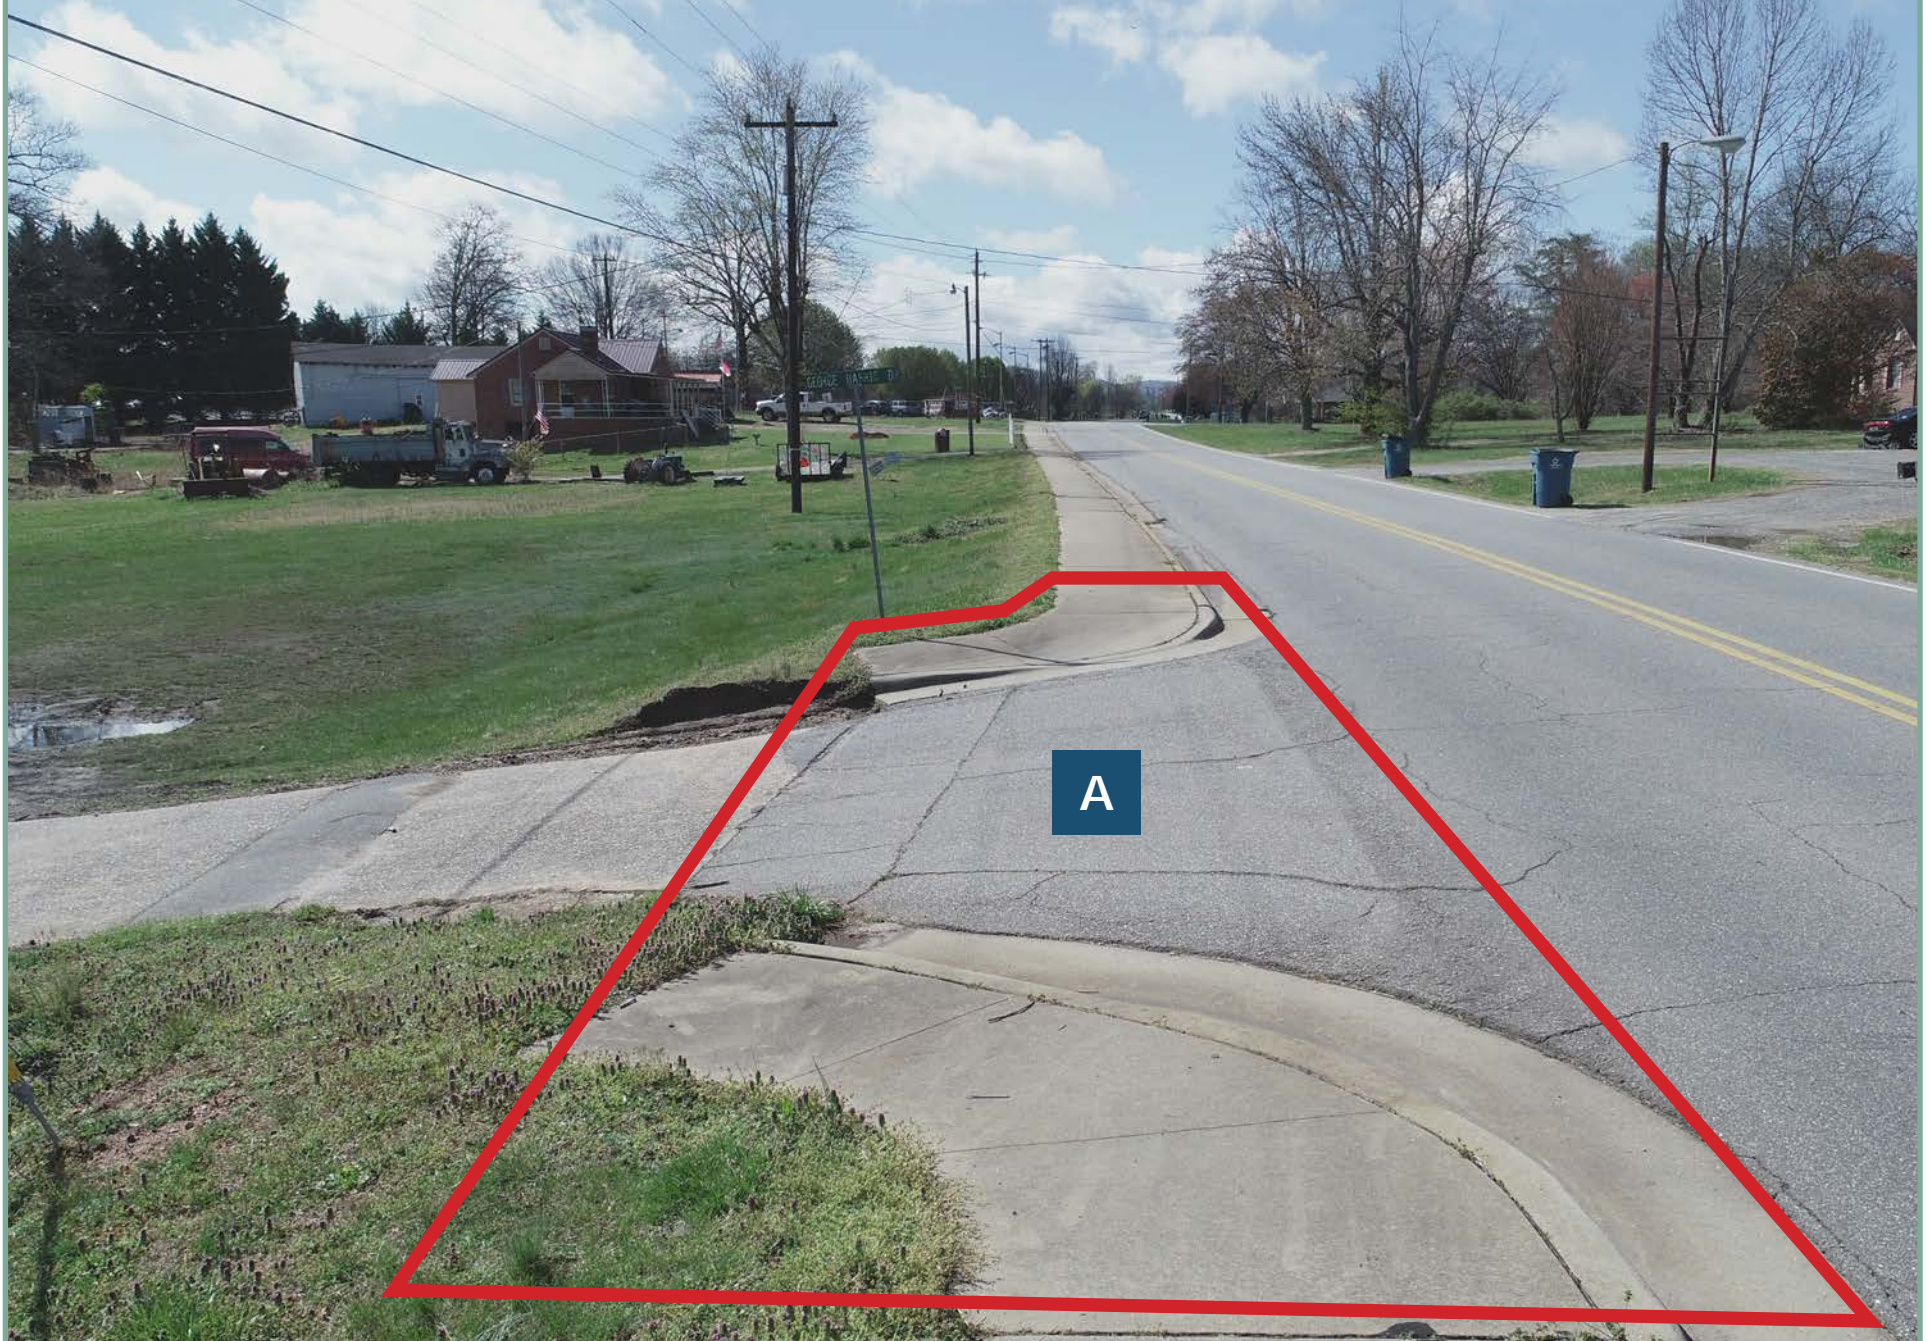
General Curb Ramp Improvements

- A » Compliant curb ramps with visually contrasting detectable warnings.
- » curb ramp standards can be found in the *Technical Standards*.
