TOWN OF GRANITE FALLS

ADA TRANSITION PLAN

DRAFT - APRIL 2021

Western Piedmont
Council of Governments

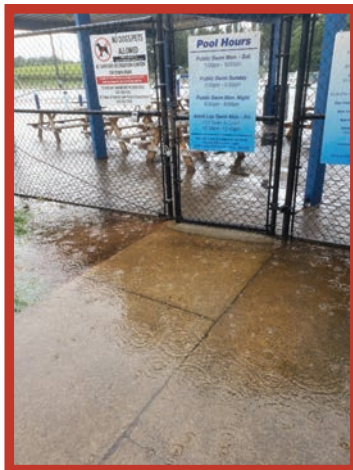
Drainage issues at pool accessible entry.

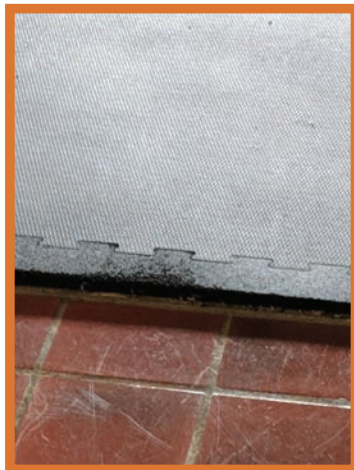
- » Transition into the Women’s Fitness Center (due to thickness of mat) is greater than ¼” high. Recommend adding mat (similar to the mat in the Men’s Fitness and Exercise Room) to assist transition.

Transition into fitness center greater than 1/4” high.

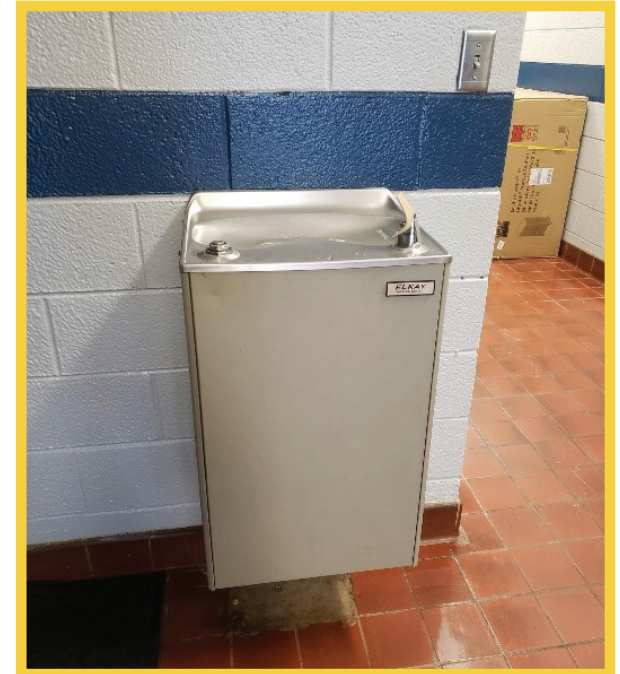
The drinking fountain outside of the gym is currently not compliant. The following are ADA Standards for drinking fountains:

Drinking fountain outside of gym.

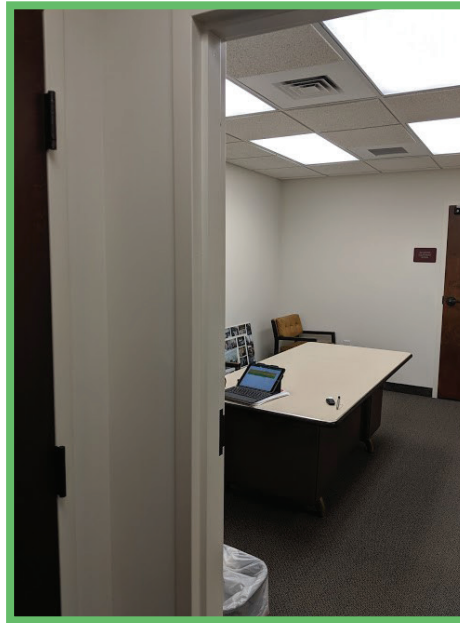
Room signs should be mounted on the wall, on the latch side of the door.

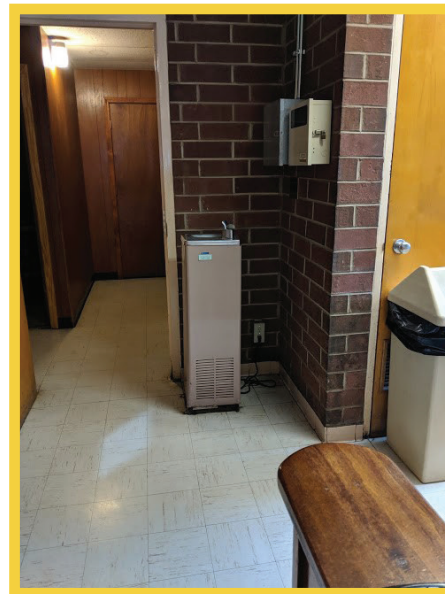
Drinking fountain is not compliant.

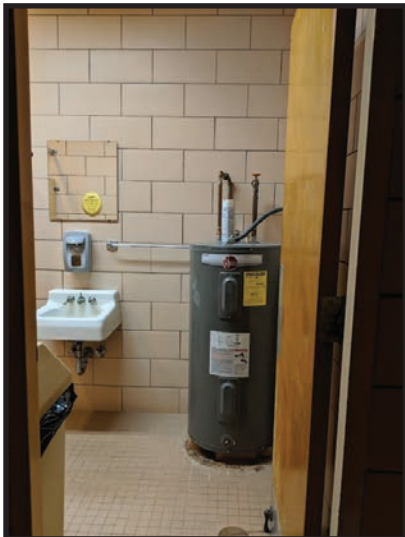
1. Doorway is 6.5 inches narrower than the minimum.

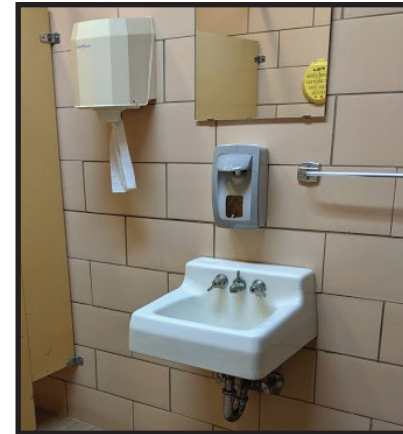
13. The hand towel dispenser is 5 inches higher than the maximum.

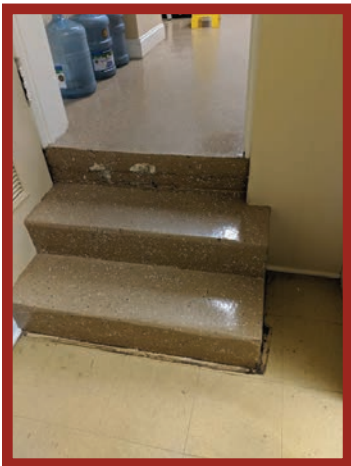
Ramp required

- » Small ramp recommended for back exit. This is a recommendation for after a ramp is installed leading to the restroom area.
- » Recommend restroom sign stating “No Public Restroom”. Members of the public can use Town Hall if necessary until bathroom is compliant.

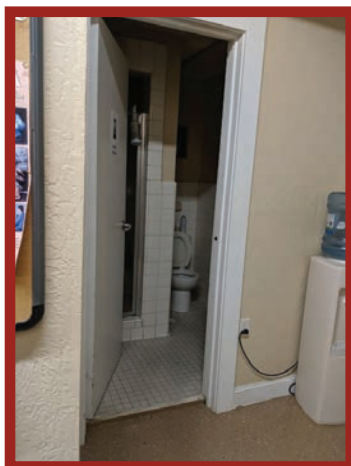
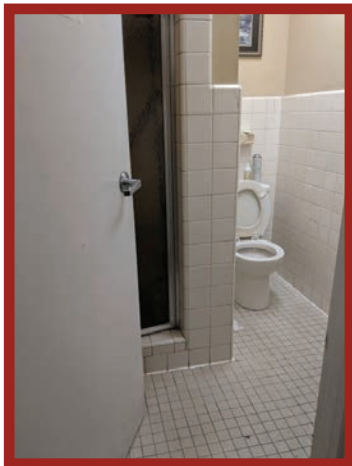
The bathroom will need to be brought outward and follow ADA Guide for Existing Bathrooms.

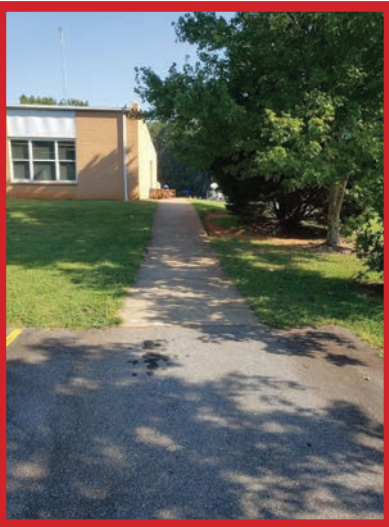
Access routes cannot exceed 2% cross slope.

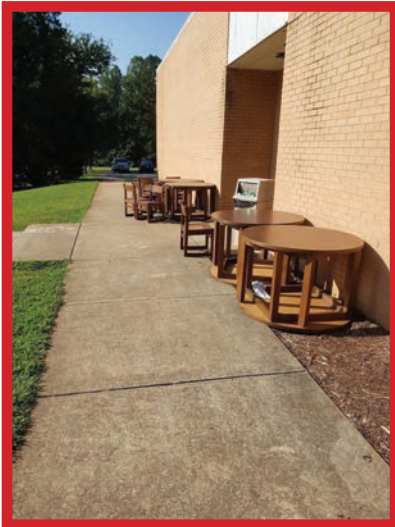
Routes must be free of obstructions.

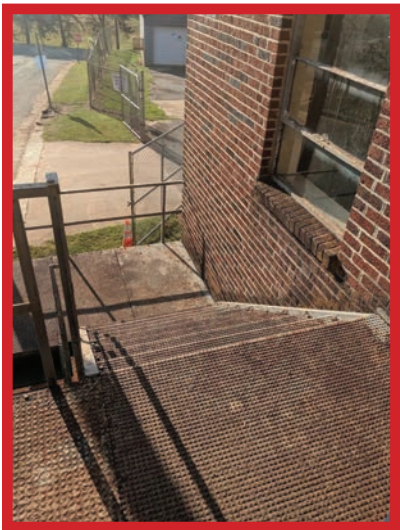
- » The back exits lead to stairwells and are not accessible to someone in a wheelchair. ADA Standards require that 60% of entrances be accessible. There should be tape on each step for visual contrast. The vertical thresholds need have better transition pieces for less of a trip hazard.

Exits lead to unaccessible stairwell.

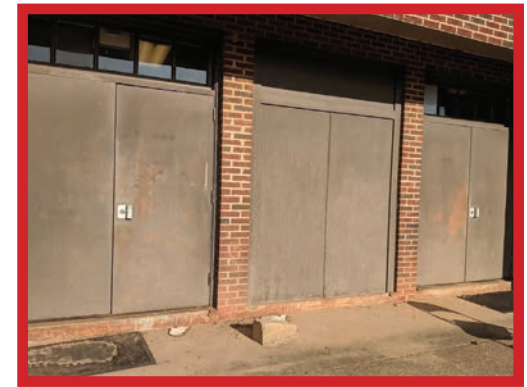
- » The transition into the doorway at the Women's Restroom exterior doors require a step up/down. There should be a ramp all the way across exterior doors on lower level.
- » The double doors at the Women's Restroom exterior doors only have one handle for access.
- » Men's lower level Exterior Doors (at Men's restroom)
 - » Left door (from inside gym)
 - » Push Pressure: 17 pounds
 - » Pull Pressure: 15 pounds
 - » Closure Time: 3.16 seconds
 - » Right door (from inside gym)
 - » Push Pressure: 17 pounds
 - » Pull Pressure: 15 pounds
 - » Closure Time: 3.11 seconds
- » The transition into the doorway at the Men's Restroom exterior doors require a step up/down. There should be a ramp all the way across exterior doors on lower level.
- » The double doors at the Men's Restroom exterior doors only have one handle for access.

Ramp needed.

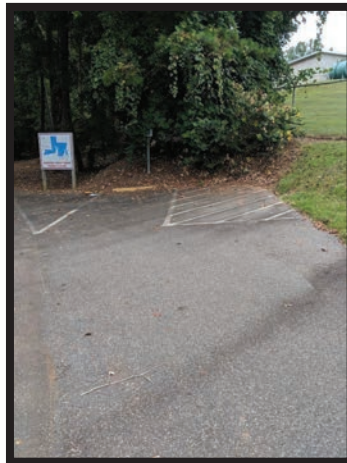
Slope is too steep to safely access the restroom from accessible space.

- » If feasible, recommend moving the accessible space next to the restrooms. It is much flatter in that location.

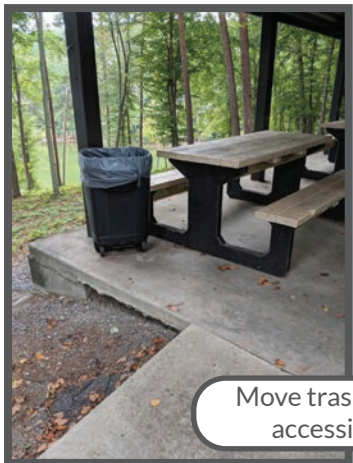
Move trash cans to an accessible area.

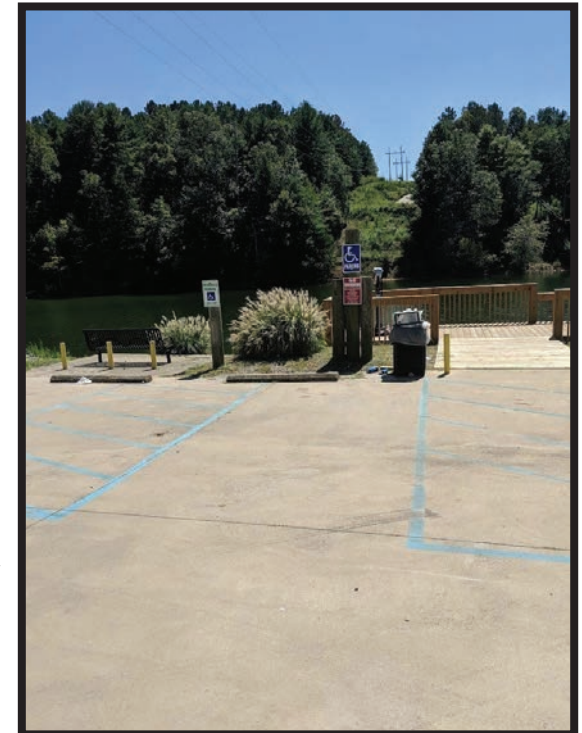
Accessible space signed for van parking but not proper dimensions. Signage needs to be mounted at least 60 inches high.

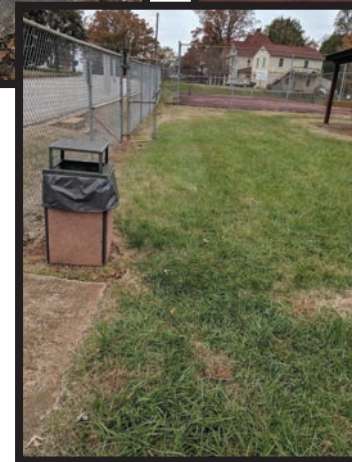
There is currently no accessible pathway. Accessible pathways should connect one of each park item to the entrance of the park and entrance/exit of the park area. This is a safety hazard for someone in a wheelchair (child or guardian).

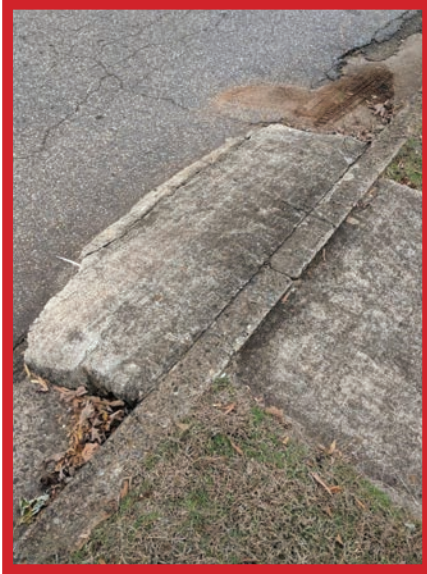
There should be a means for someone wheelchair bound to safely access the play area from Stirling Street. The ramp leading into the park from the road is too steep and not flush with the roadway.

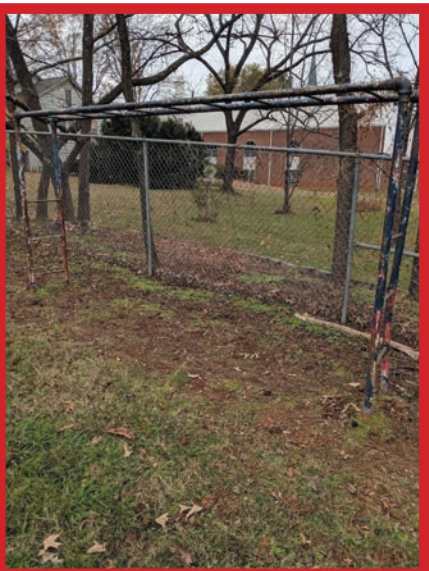
Recommend removing older playground climbing equipment.

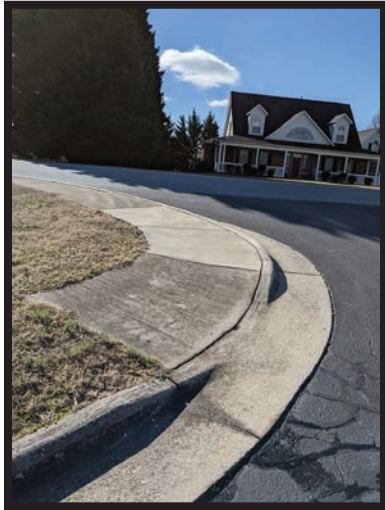
Site arrival – curb ramp above leading from the sidewalk along Pinewood Road to the park entry is too steep.

- » Cross slope: 8.1%
- » Running slope: 10.7%

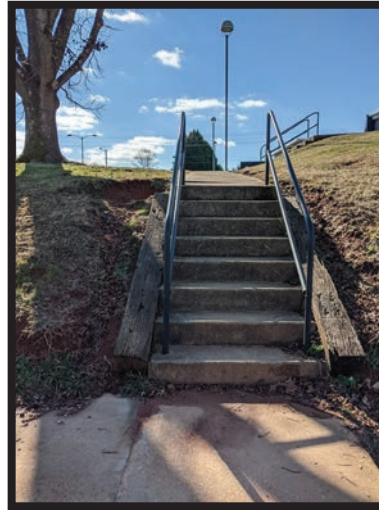
The staircase above is damaged and could pose a trip hazard. There should be signage at the staircase showing those in wheelchairs the accessible route to the play area below.

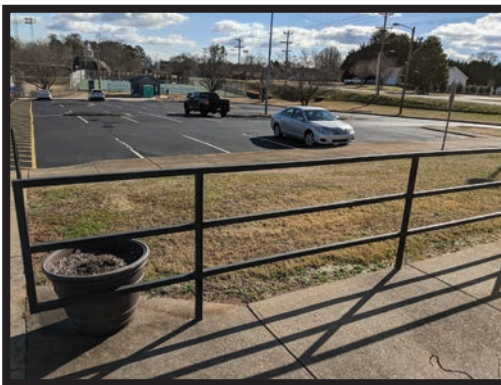
Ramps with railing must have a barrier installed 4 inches from the ramp surface. This allows for cane detection and safer wheelchair stops.

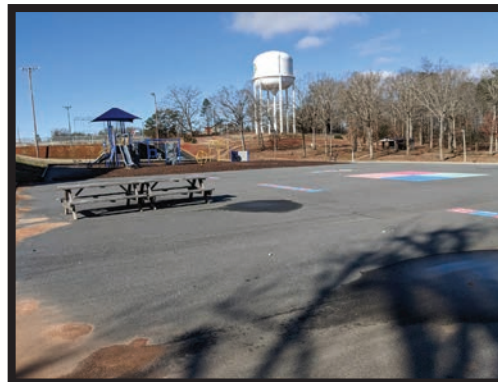
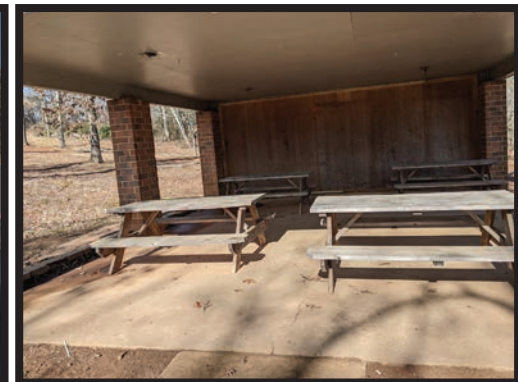
Picnic areas should offer a portion of its tables with longer tops to accommodate knee space for those in wheelchairs. There should also be sufficient space for navigation between tables.

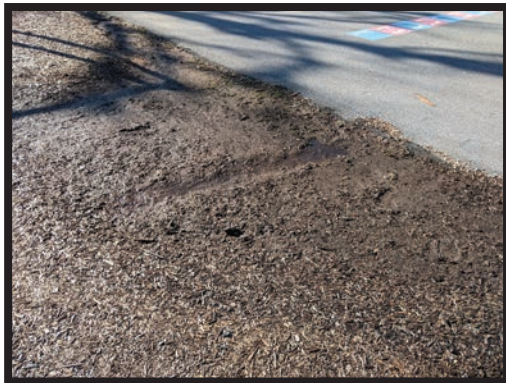
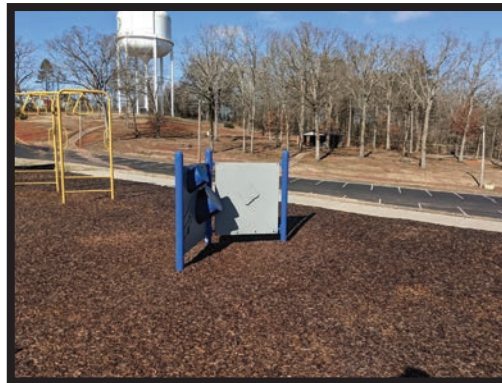
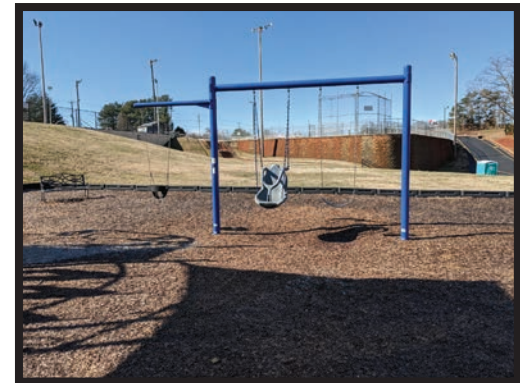
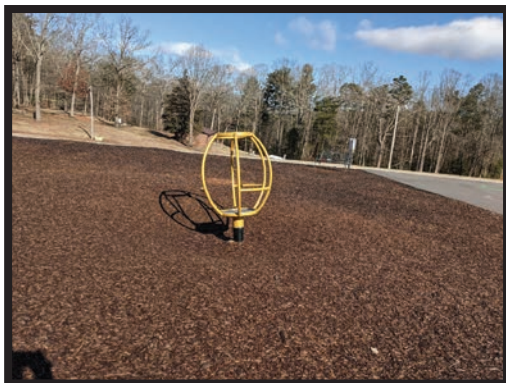
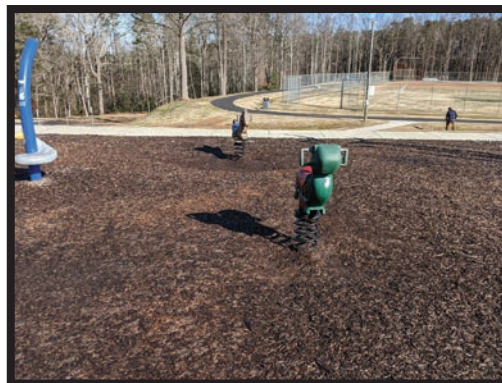
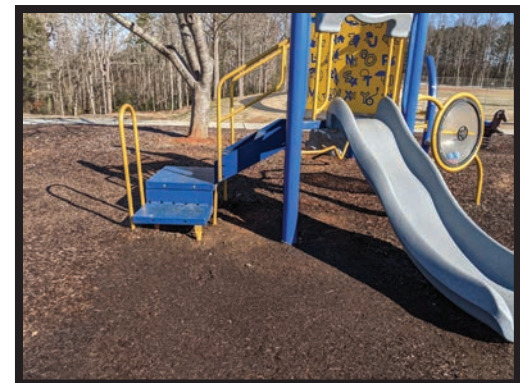
- » Mulched surface is too difficult for mobility in the play area next to the recreation center. Mulch should be replaced with an accessible surface along accessible pathways and next to accessible play elements. Please note that while surfaces such as cement are accessible, they can also pose a safety hazard in play areas if located too close to elevated and some ground level components.

- » The asphalt play area currently meets ADA Standards for surface materials.
- » An accessible route should connect one of each play element to the play area entrance if possible. An accessible route is at least 36 inches wide and is stable, firm, and slip-resistant. The compliant surface must extend to the play element for safe access for all users. Since the following play elements offer different play experiences, one of each must be included on the accessible route. Please refer to the pictures below:

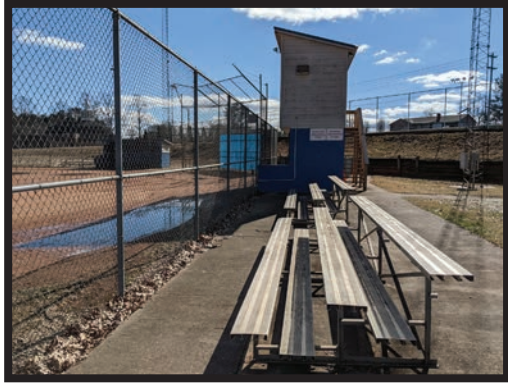
Bleachers should have a ground area as close to the bleachers as possible designated for wheelchair spaces. Smaller bleachers only require 1 space. The space must be 36 inches wide and 48 inches deep.

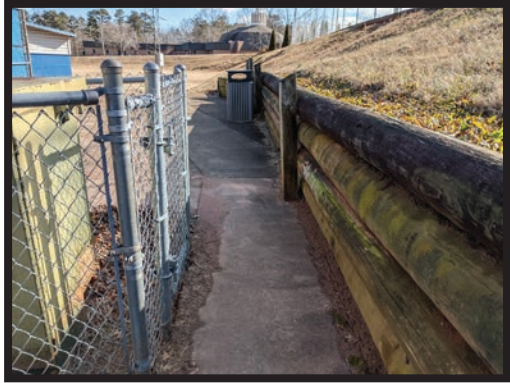
The pathway above is too narrow for an accessible route at the entrance to the bleachers.

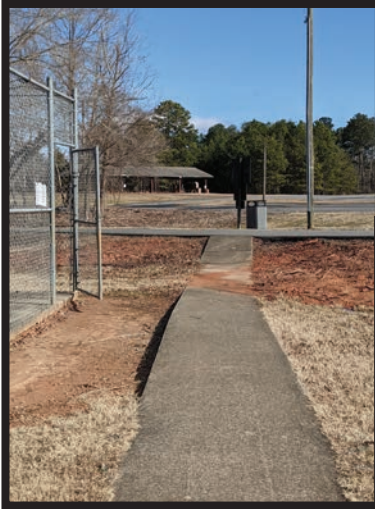
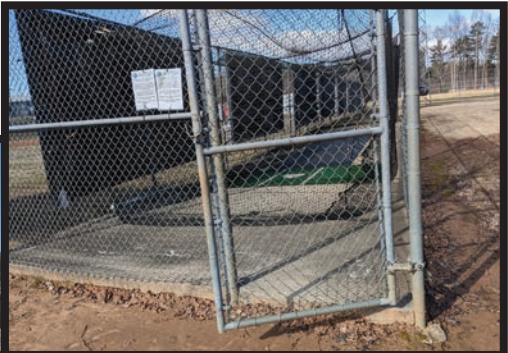
The batting cage (pictured above) is not accessible. Extend the sidewalk to the batting cage entrance/exit.

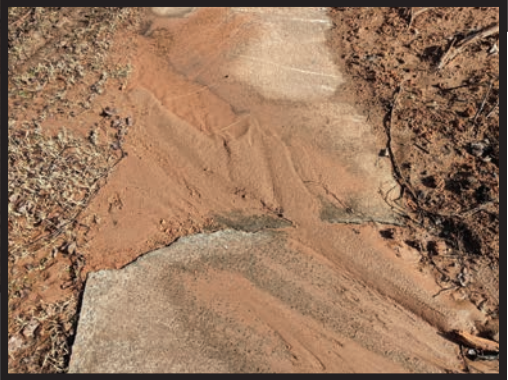
The sidewalk at the batting cage exceeds the 5% running slope allowed when not following a roadway. The sidewalk is cracked with drainage issues creating a hazardous travel path.

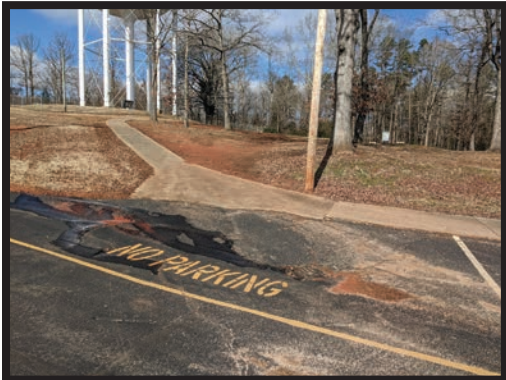
The sidewalk located between the water tower and picnic shelter exceeds the permitted 5% running slope that sidewalk can reach if not following a roadway. The bottom of the hill has an uneven surface with a storm water drain. Safety improvements are recommended at the bottom of the hill, as well as level resting areas on large hills with a running slope exceeding 5%.

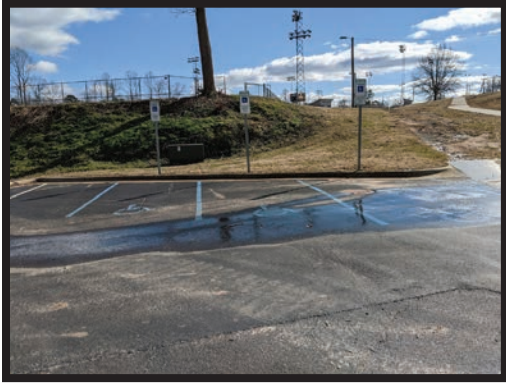
The accessible spaces pictured above are missing access aisles. These spaces must be restriped in accordance with Priority 1 – Approach and Entrance in Appendix B.

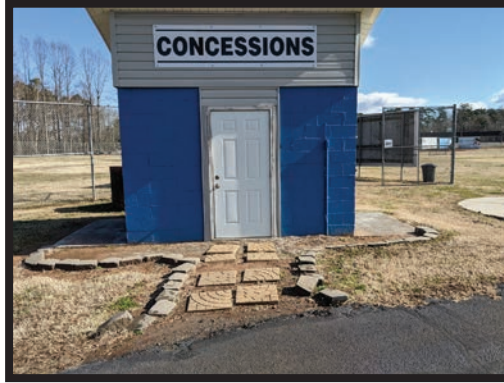
If the concessions building (pictured above) is still in operation, it is not accessible to all users. An accessible route must lead up to where concessions are sold.

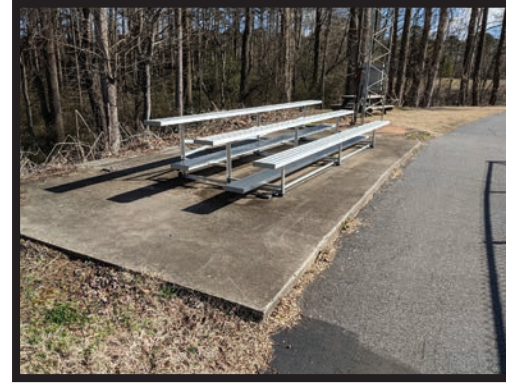
Not all bleacher areas are accessible. The bleacher entrance should be flush with the adjoining asphalt.

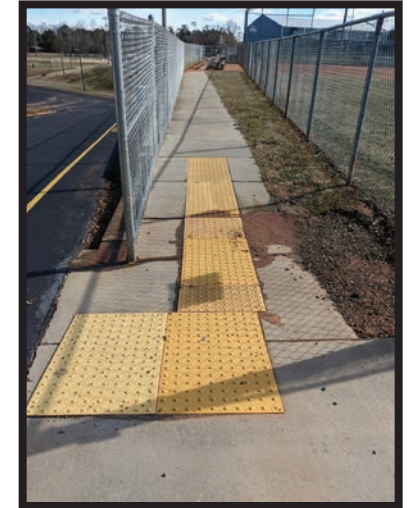
Detectable warnings are only necessary where pedestrians are crossing a roadway. The detectable warnings next to the gate are unnecessary.

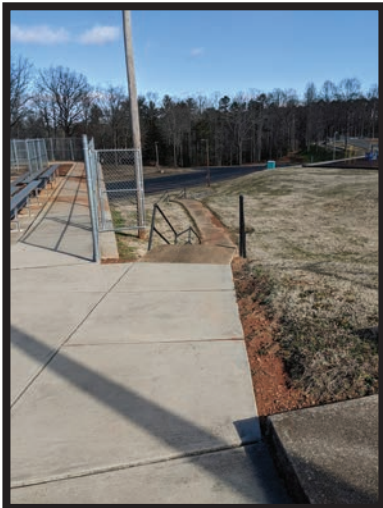
Signage is necessary at stairways showing guests alternative accessible routes and where they lead.

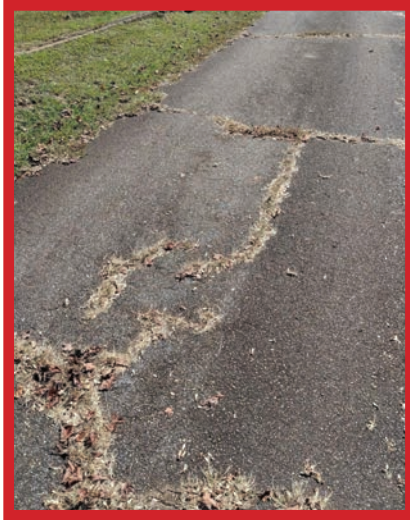
Main roadways should be paved.

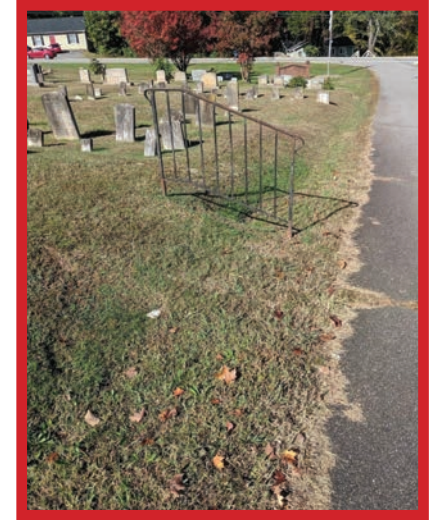
Abrupt level changes should be handled with a ramp.

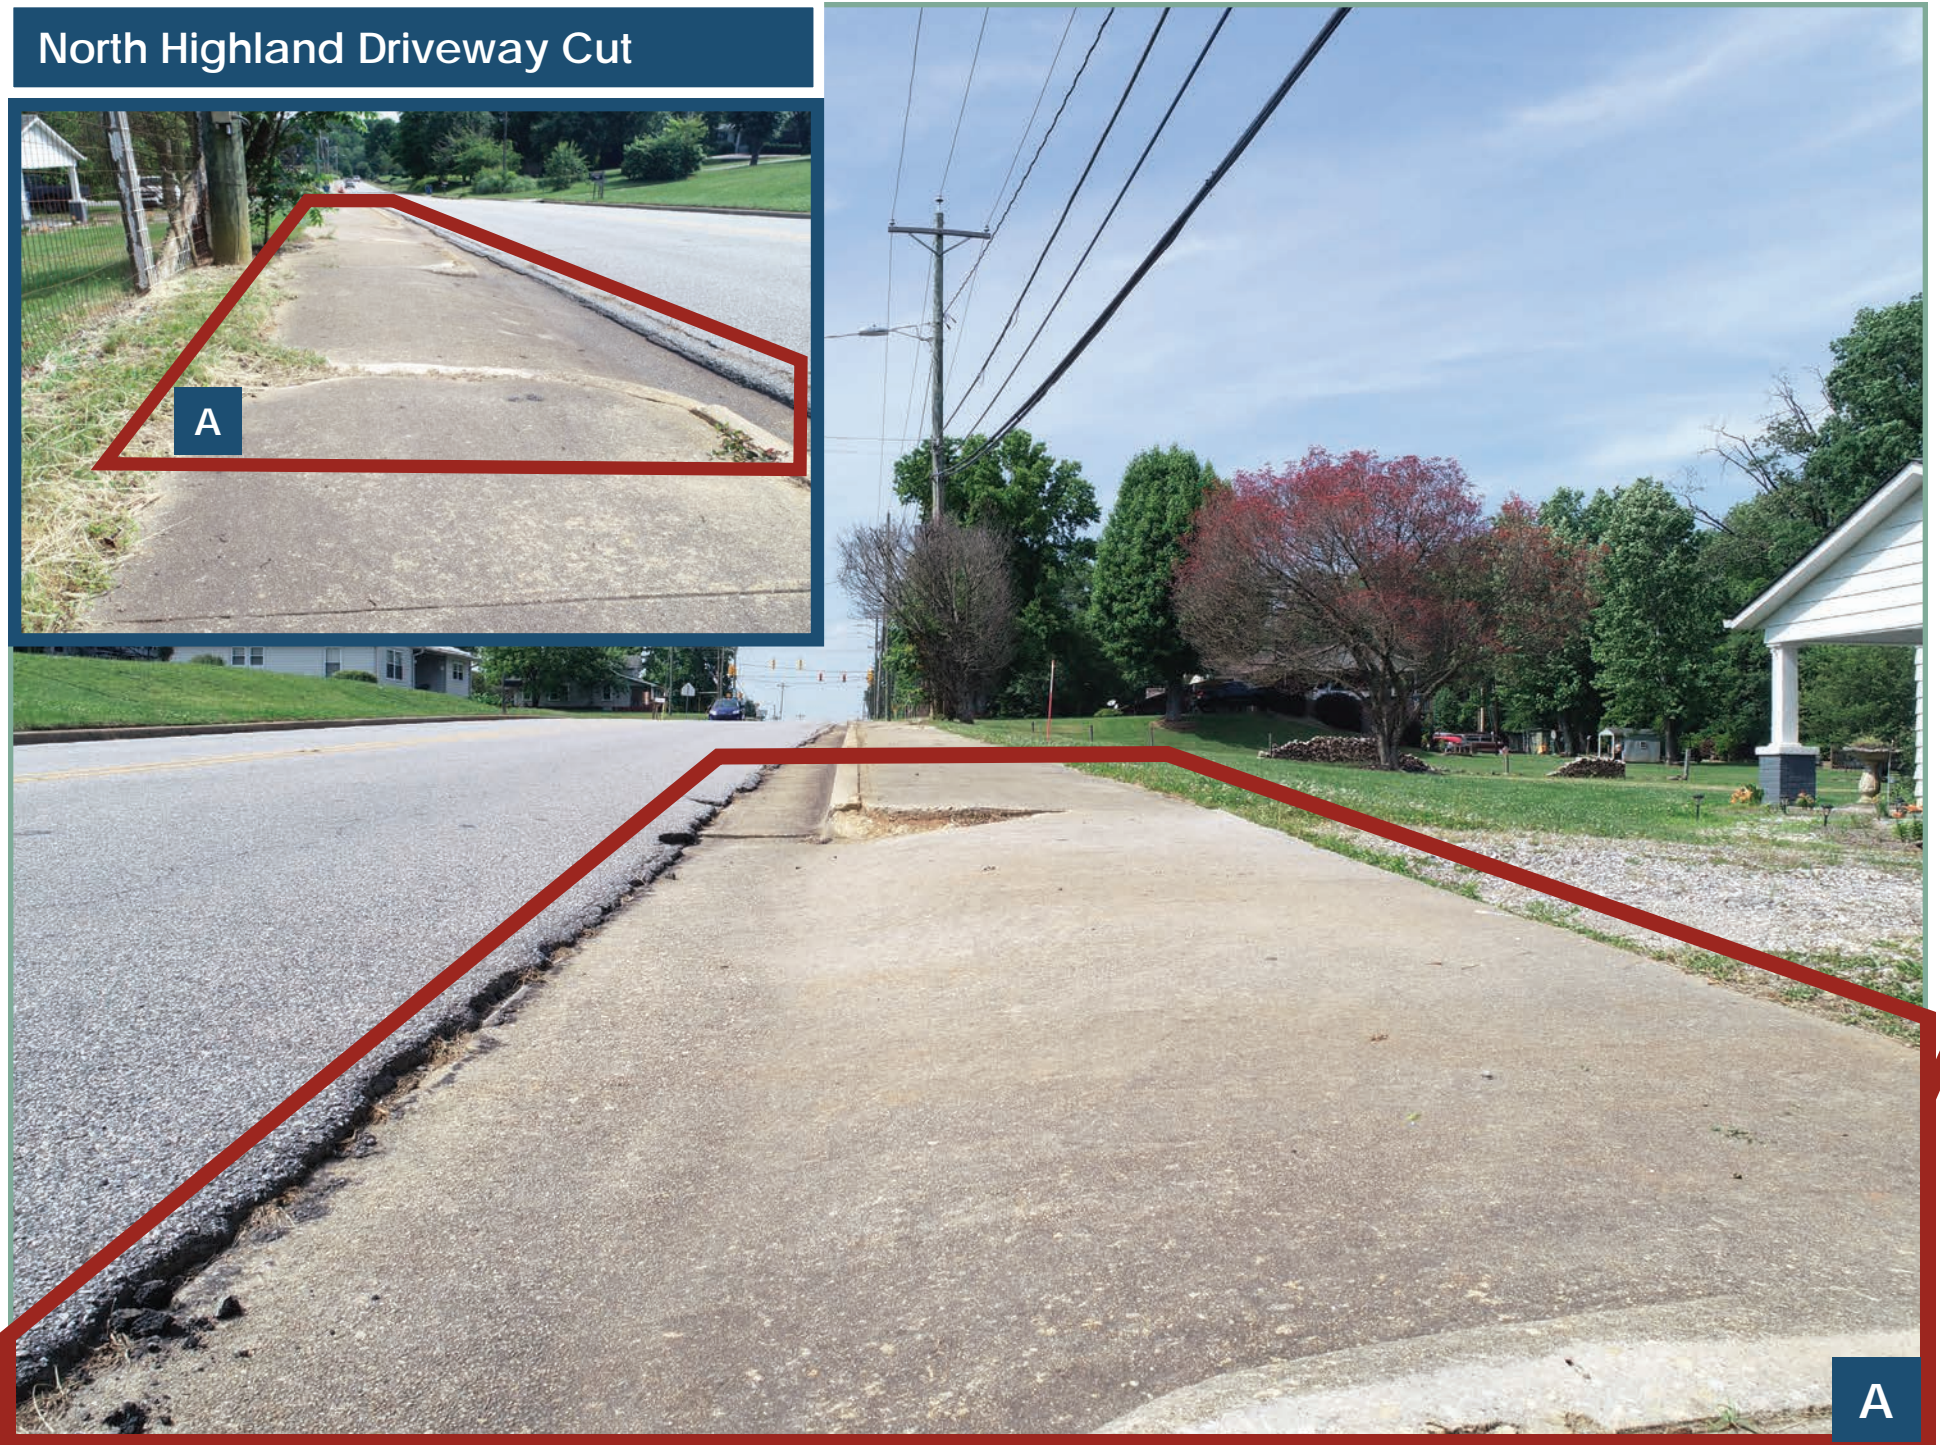
North Highland Driveway Cut

- » Driveway cuts must maintain a 4 foot wide, level pedestrian path of travel surface for the entire driveway cut.
- » Driveway cuts cannot exceed a 2% cross slope. The cross slope is measured perpendicular to the pedestrian path of travel.
- » Driveway cuts cannot have a rapid grade change at the flare. Flares at the beginning and end of each driveway cut should be out of the 4 foot wide pedestrian path of travel.

- A
 - » Square-up intersection.
 - » Compliant curb ramp with visually contrasting detectable warning at crosswalk.
- B
 - » Pedestrian signage at crosswalk.
 - » Highly visual crosswalk.
 - » Stop bar for motorists should be 4 ft. behind crosswalk.
- C
 - » Recommendation: Consolidate driveway cut.
