Sawmills

ADA Transition Plan

Adopted on November 19, 2024

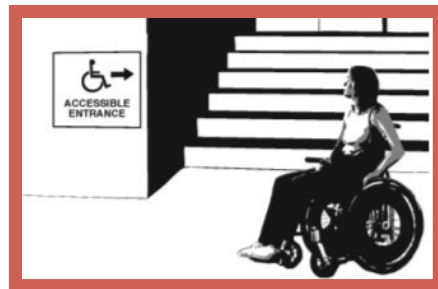
Inaccessible entrances must have signage for the nearest accessible entrance.

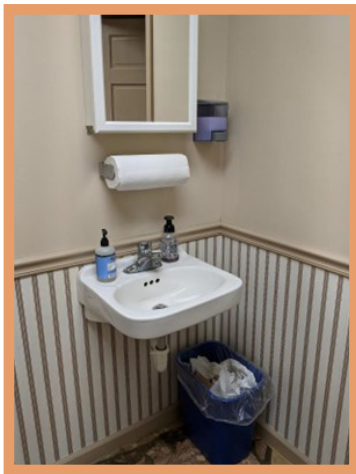
Lower mirror.

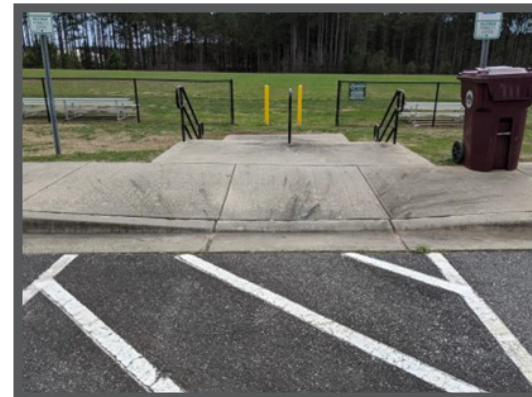
The curb ramp closest to the soccer field has a top landing right next to the stairs. Recommend high-viz striped tape on the stairs as well as directional signage showing the nearest accessible route. (high recommendation)

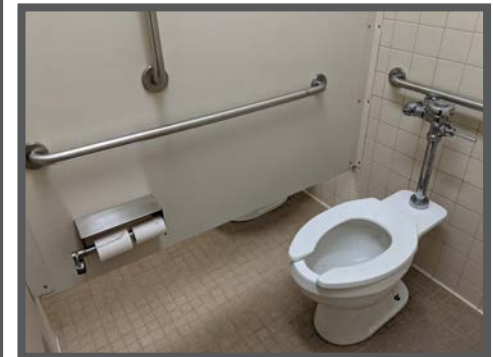
Men's Restroom

- » The operable parts of the light switch can be no higher than 48" above the floor. Currently, the light switch is mounted 50" above the floor. *If constructed before 3/15/2012 and a parallel approach is provided, controls can be 54" above the floor.*

- » The bathroom door is currently very difficult to push open. Generally, ADA Standards require 5 pounds of maximum force for opening doors. There are, however, no standards for exterior doors. The maximum amount of recommended force is 10 pounds with a 5 second closure time.

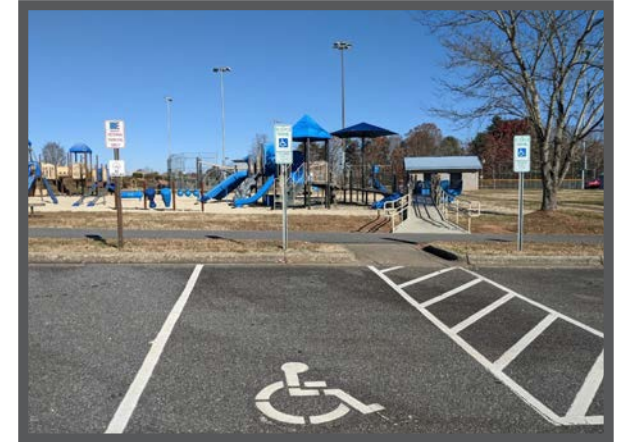
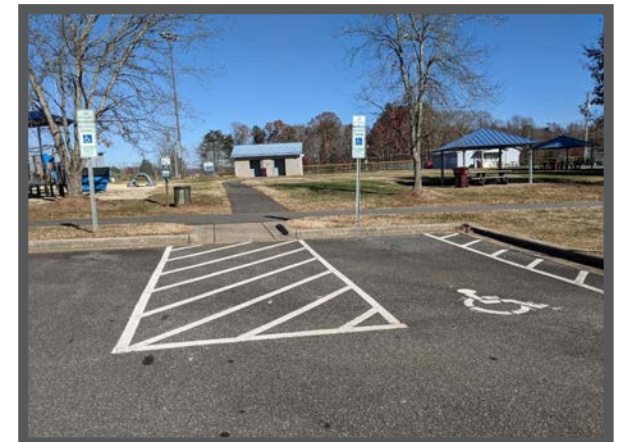
- » Measurement: 8ft wide
- » Accessible Van Space #2:
 - » Cross Slope Ranges: 3 – 3.8%
 - » Running Slope Ranges: 3.3 – 6.9%
 - » Measurement: 8 ft wide

- » Shared access aisle for van accessible spaces
